Report of the

# PRESIDENTIAL COMMISSION

*on the Space Shuttle  
Challenger Accident*

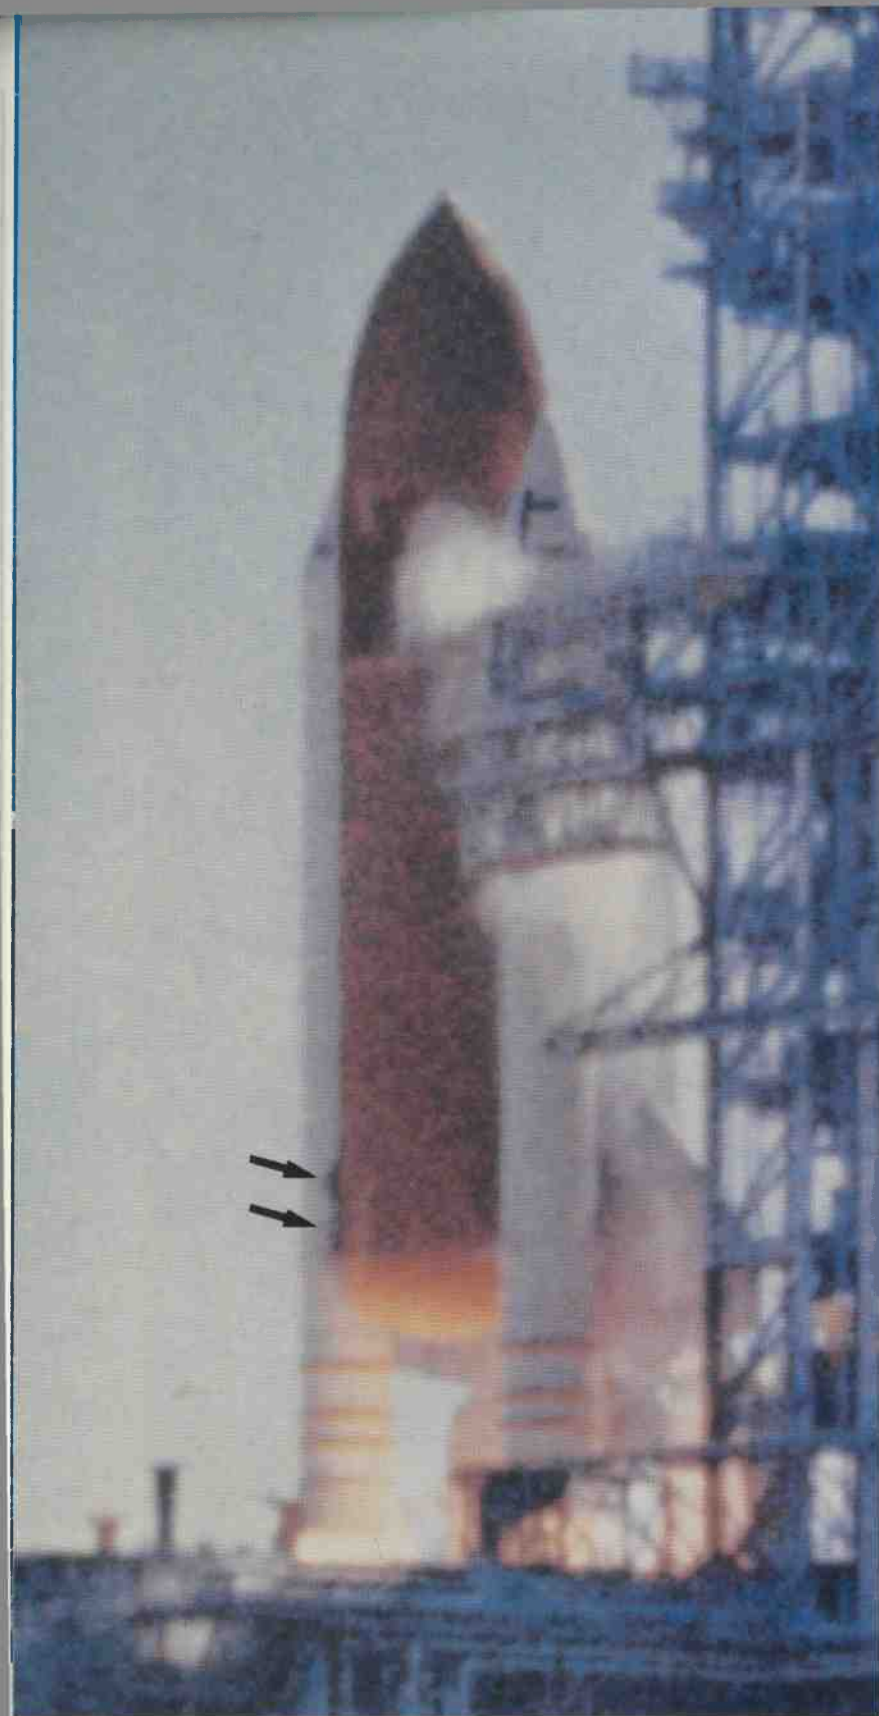
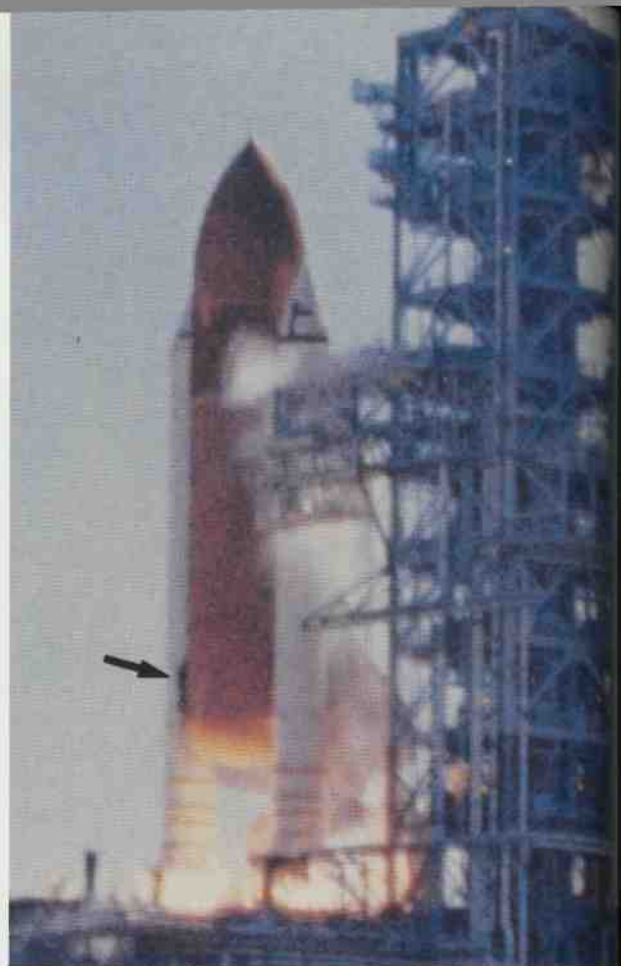
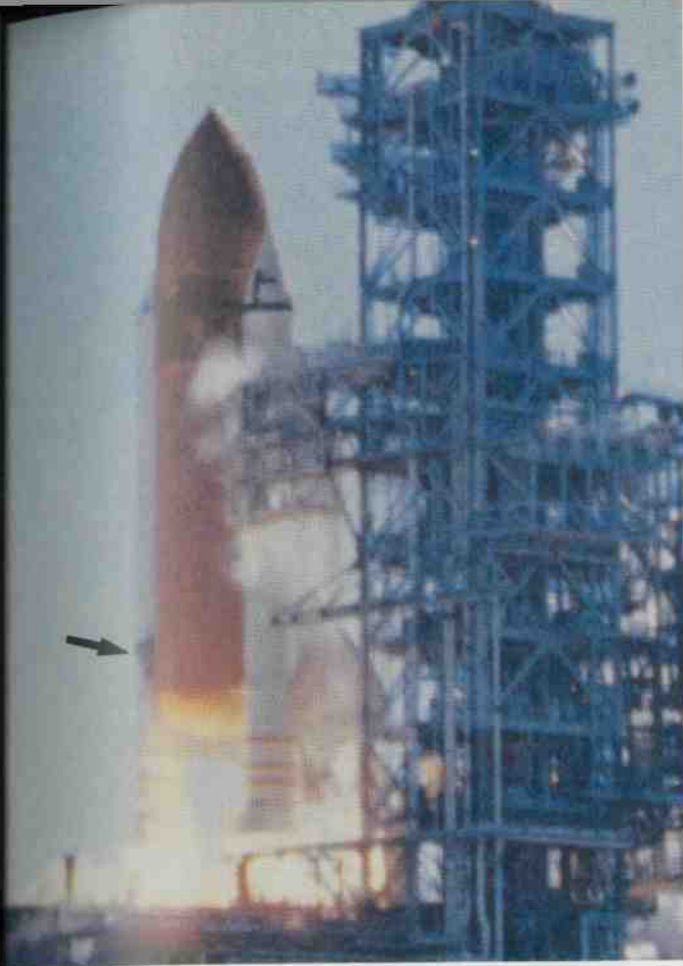
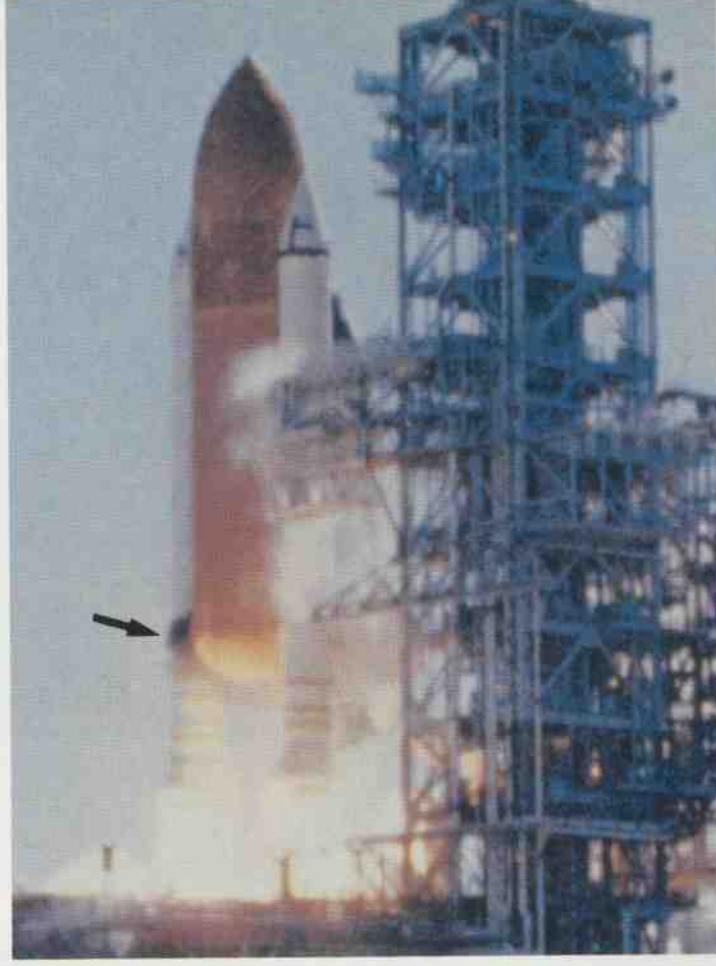
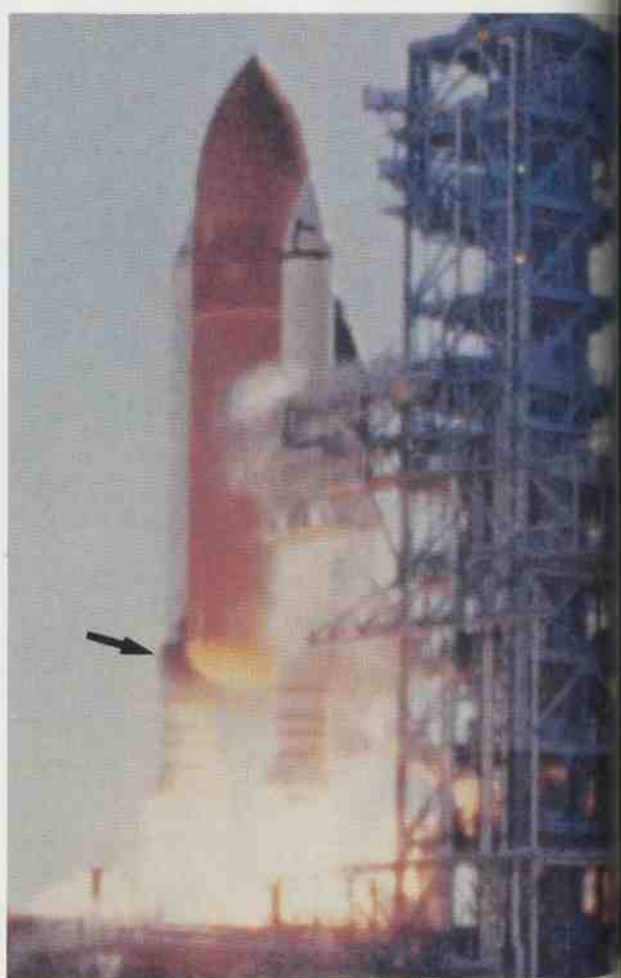
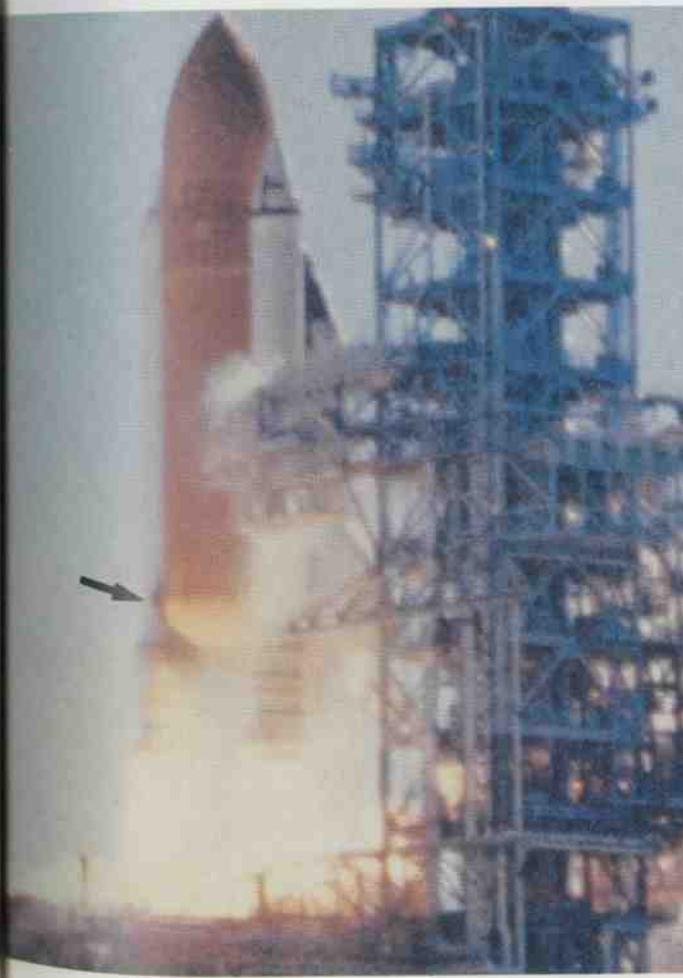
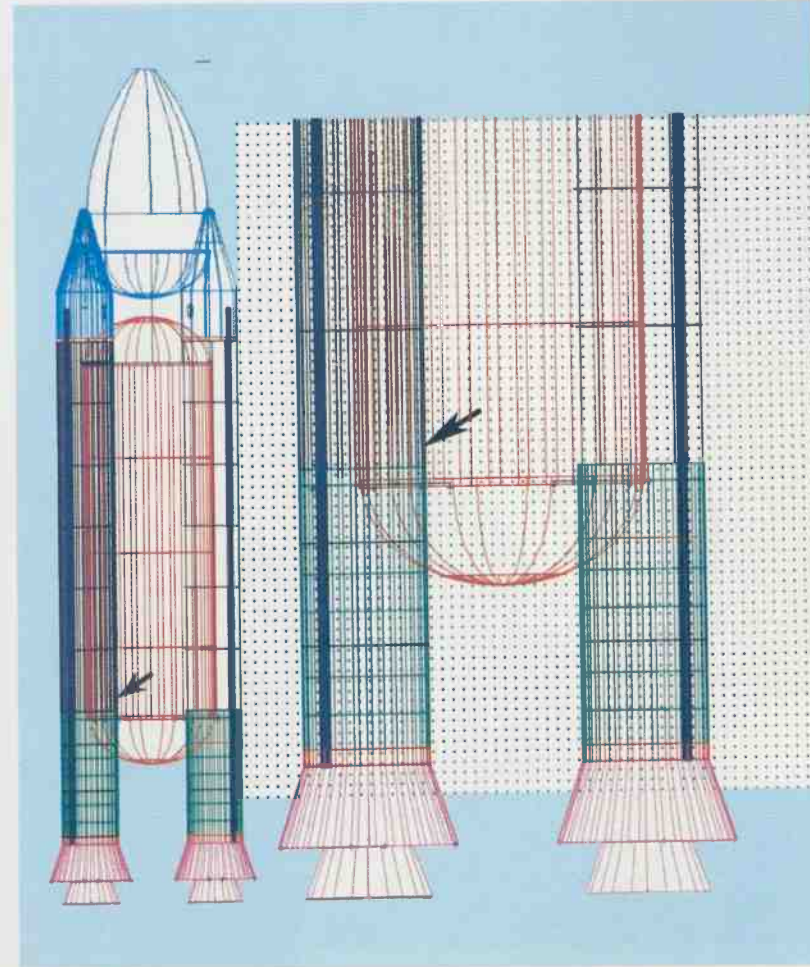
Multiple smoke puffs are visible in the photo above (arrows). They began at .836 seconds and continued through 2.500 seconds, occurring about 4 times a second. Upward motion of the vehicle caused the smoke to drift downward and blur into a single cloud. Smoke source is shown in the computer generated drawing (far right).

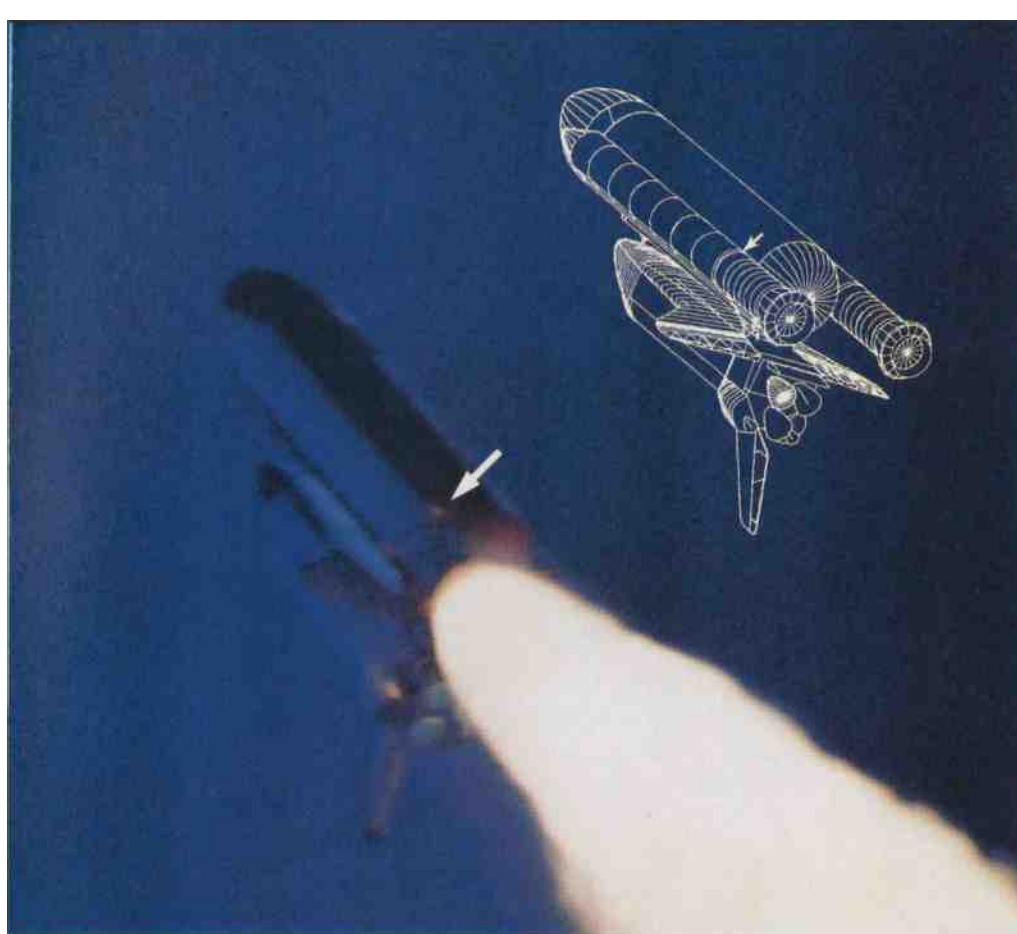
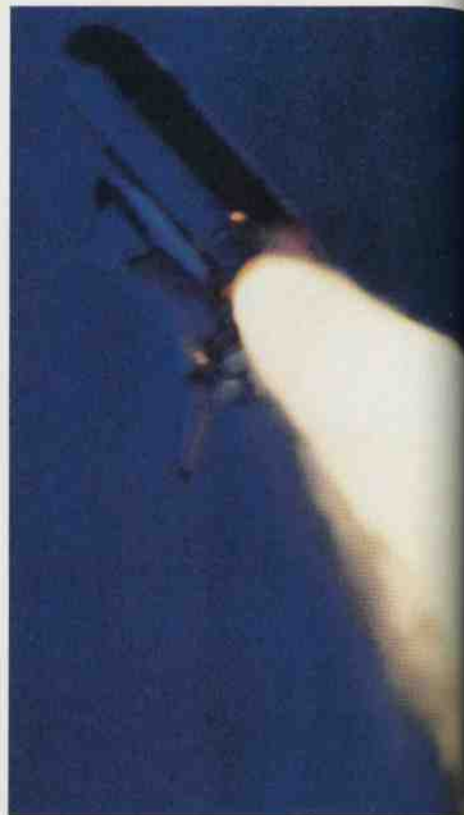
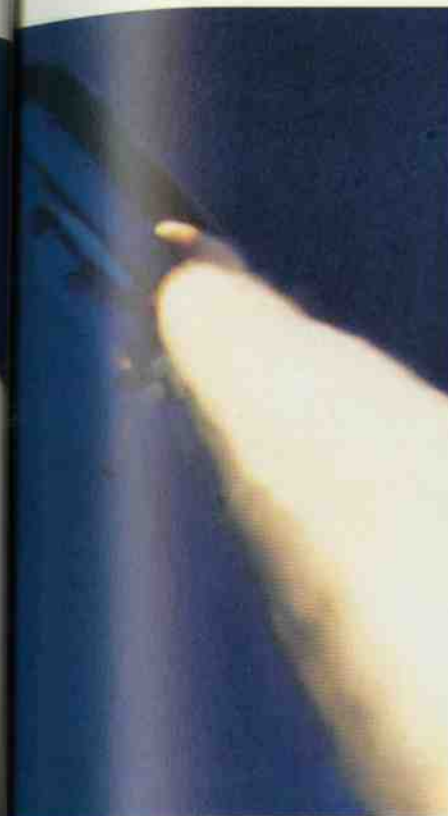
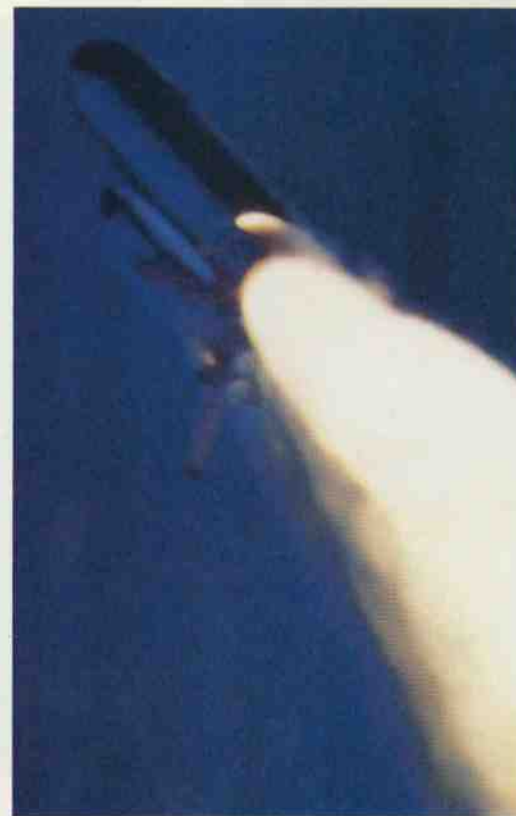
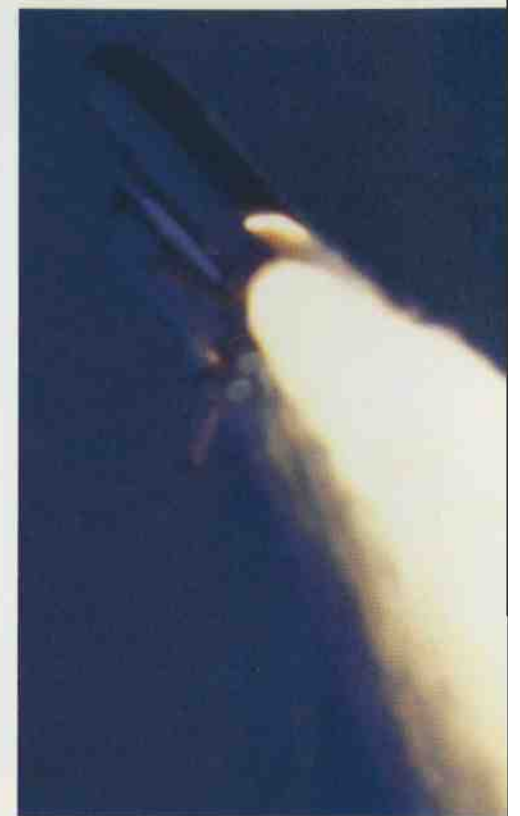
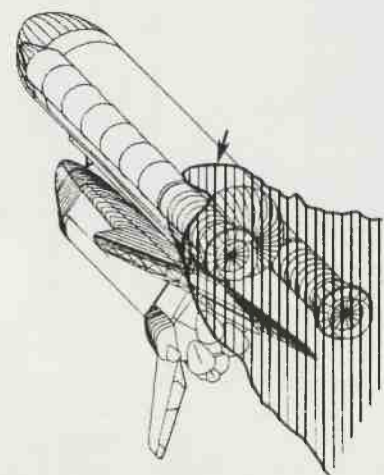
At 58.788 seconds, the first flicker of flame appeared. Barely visible above, it grew into a large plume and began to impinge on the External Tank at about 60 seconds. Flame is pinpointed in the computer drawing between the right booster and the tank, as in the case of earlier smoke puffs. At far right (arrow), vapor is seen escaping from the apparently breached External Tank.

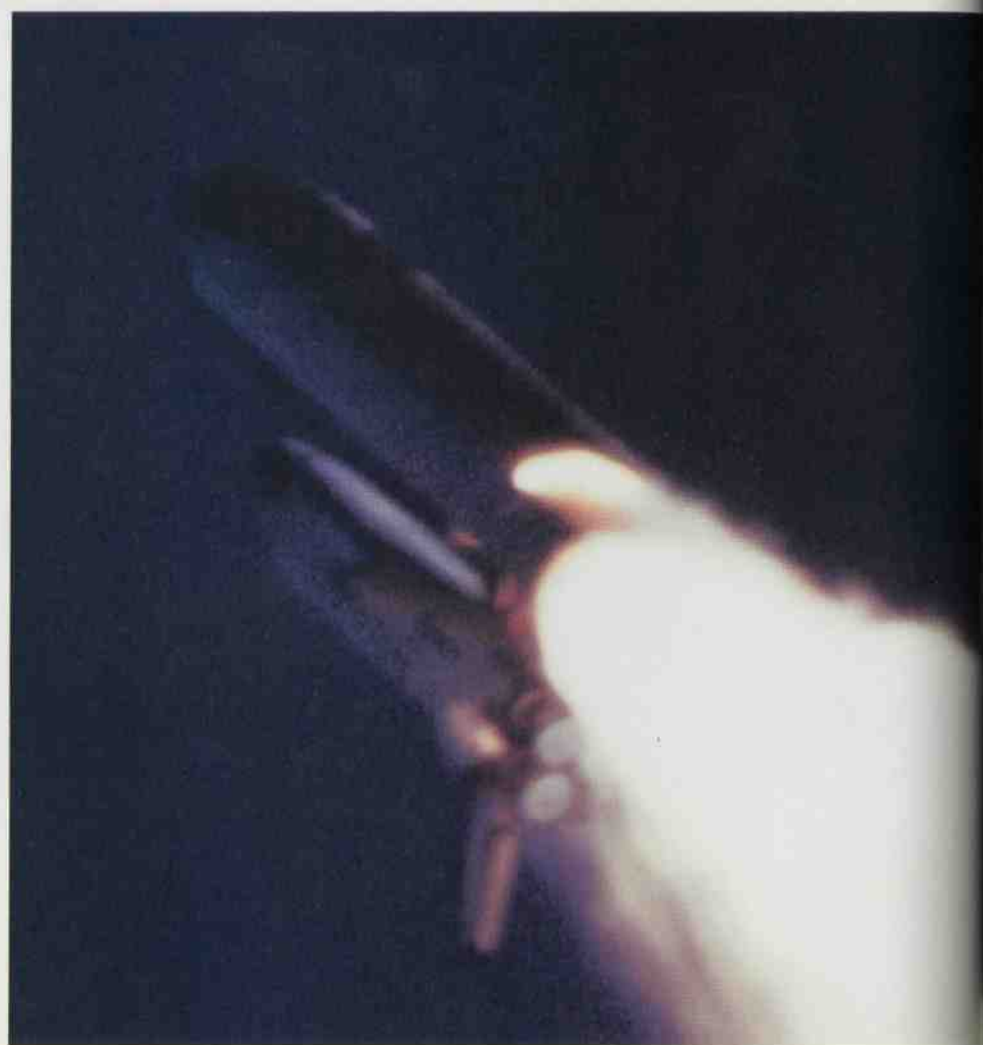
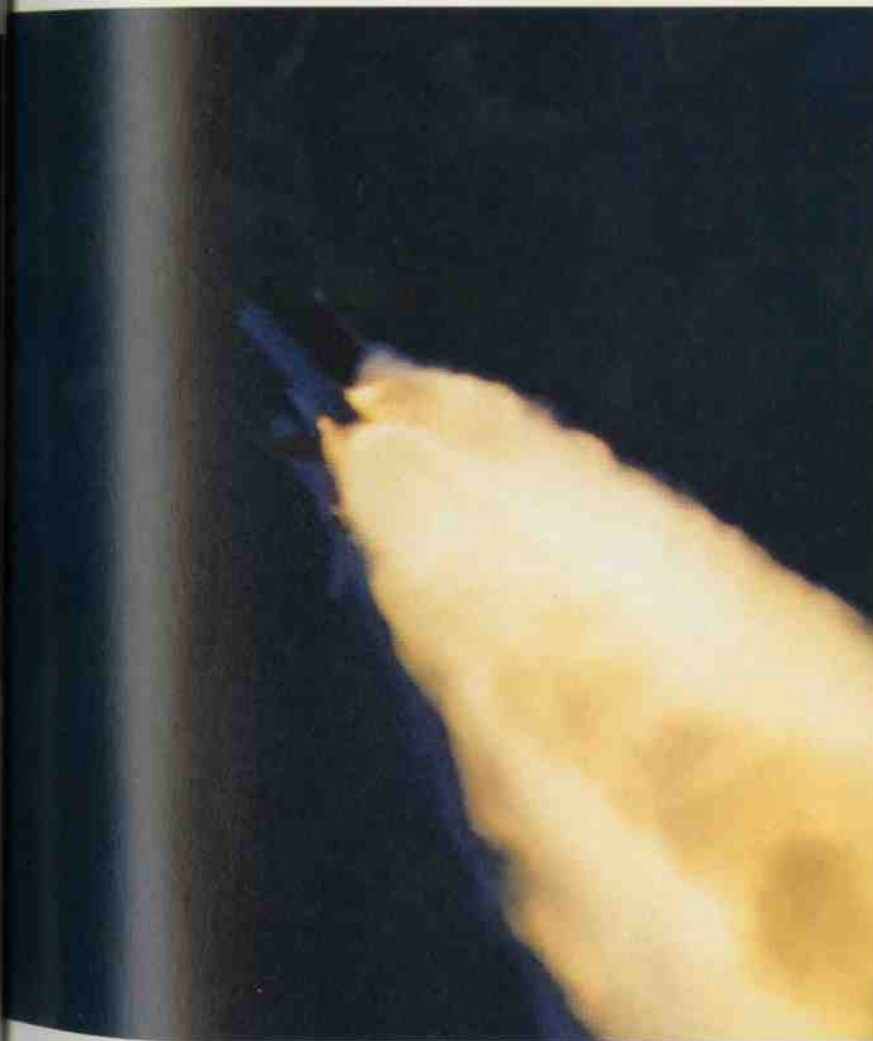
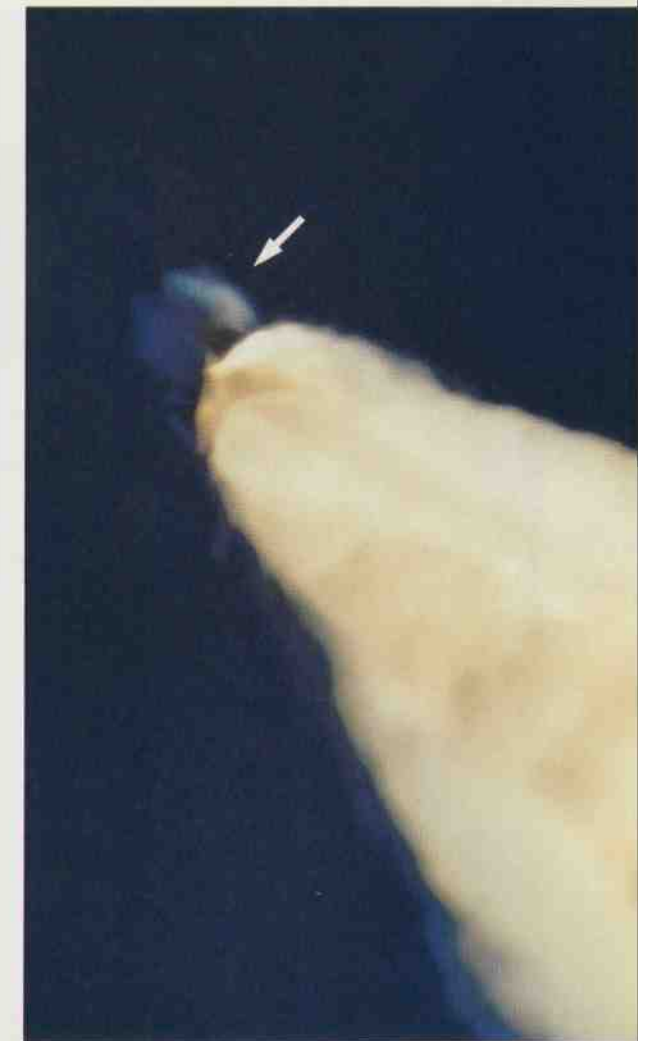
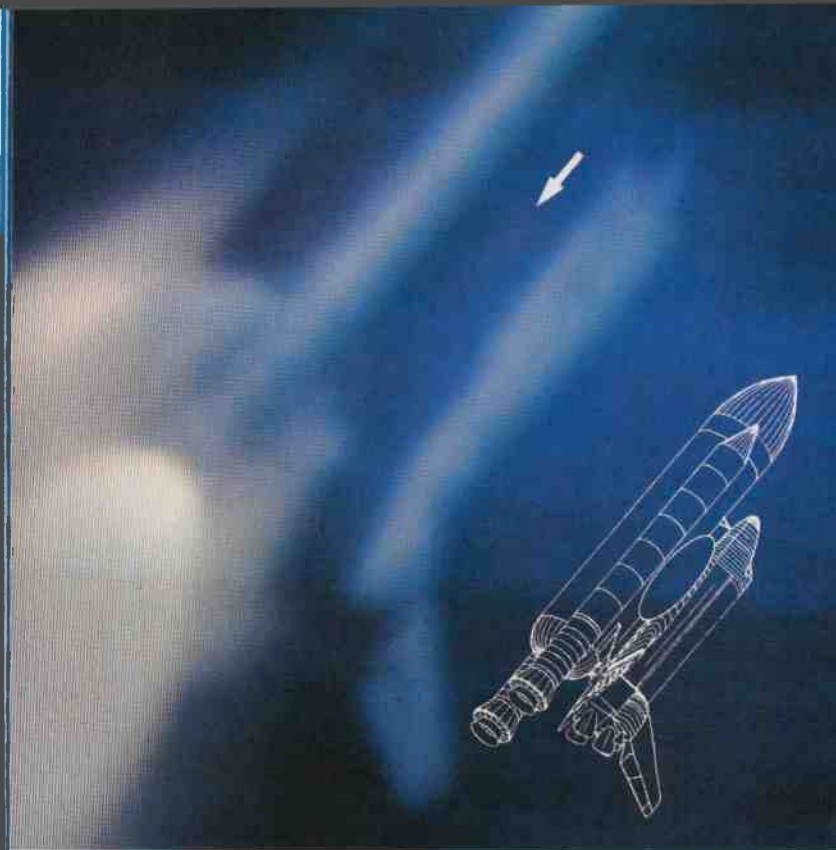
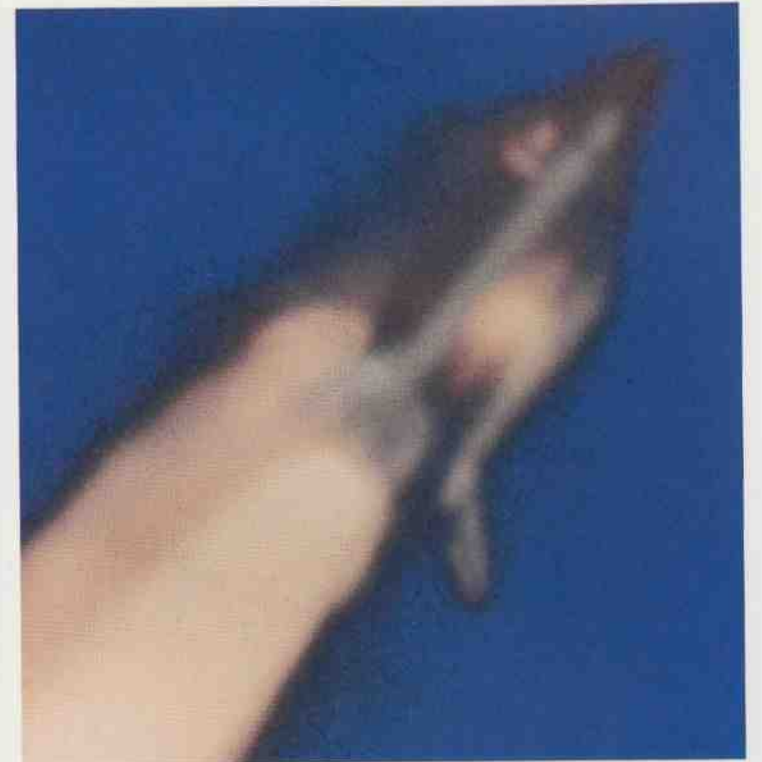
Camera views indicate the beginning of rupture of the liquid hydrogen and liquid oxygen tanks within the External Tank. A small flash (arrows above) intensified rapidly, then diminished. A second flash,

attributed to rupture of the liquid oxygen tank, occurred above the booster/tank forward attachment (below left) and grew in milliseconds to the maximum size indicated in the computer drawing.

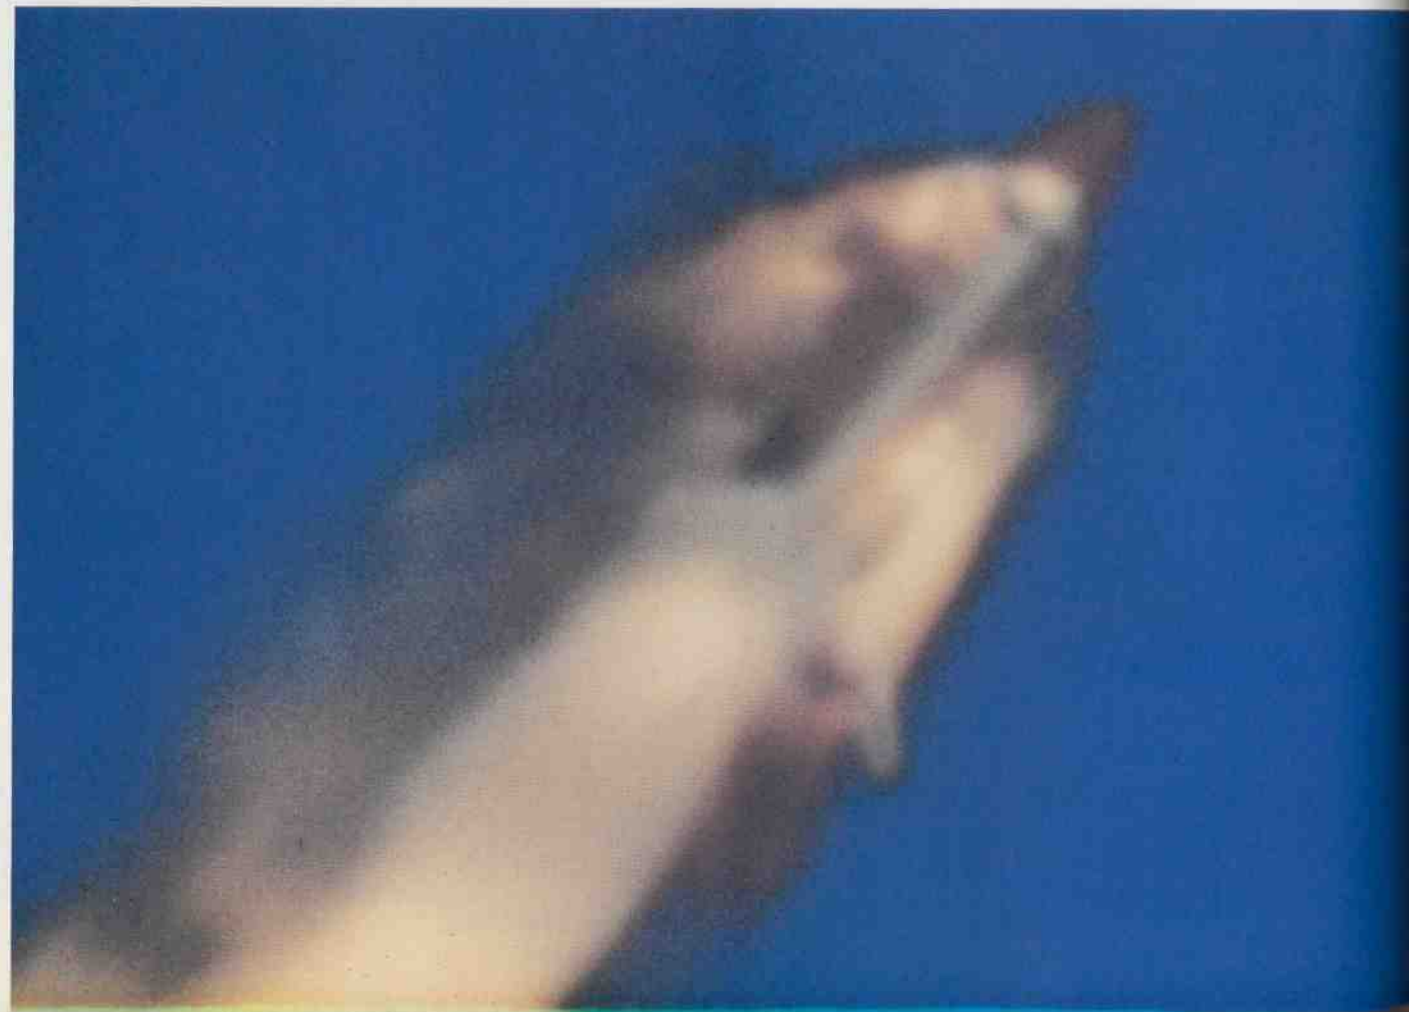
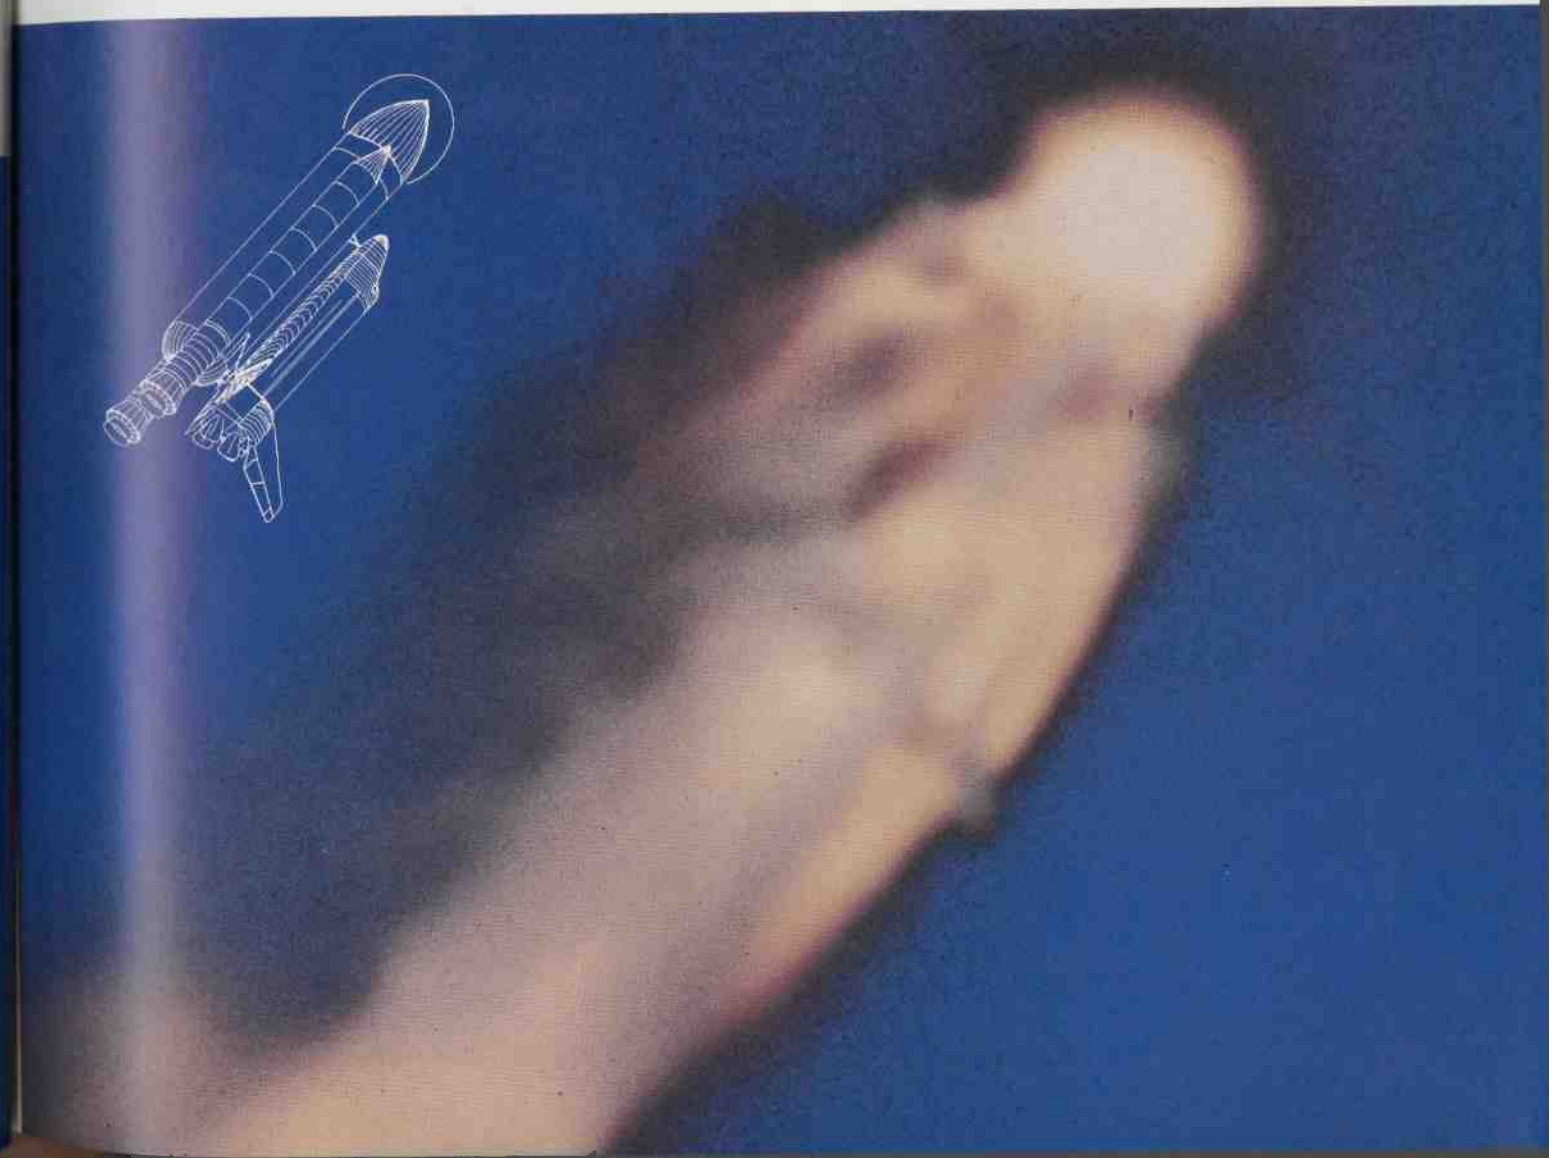
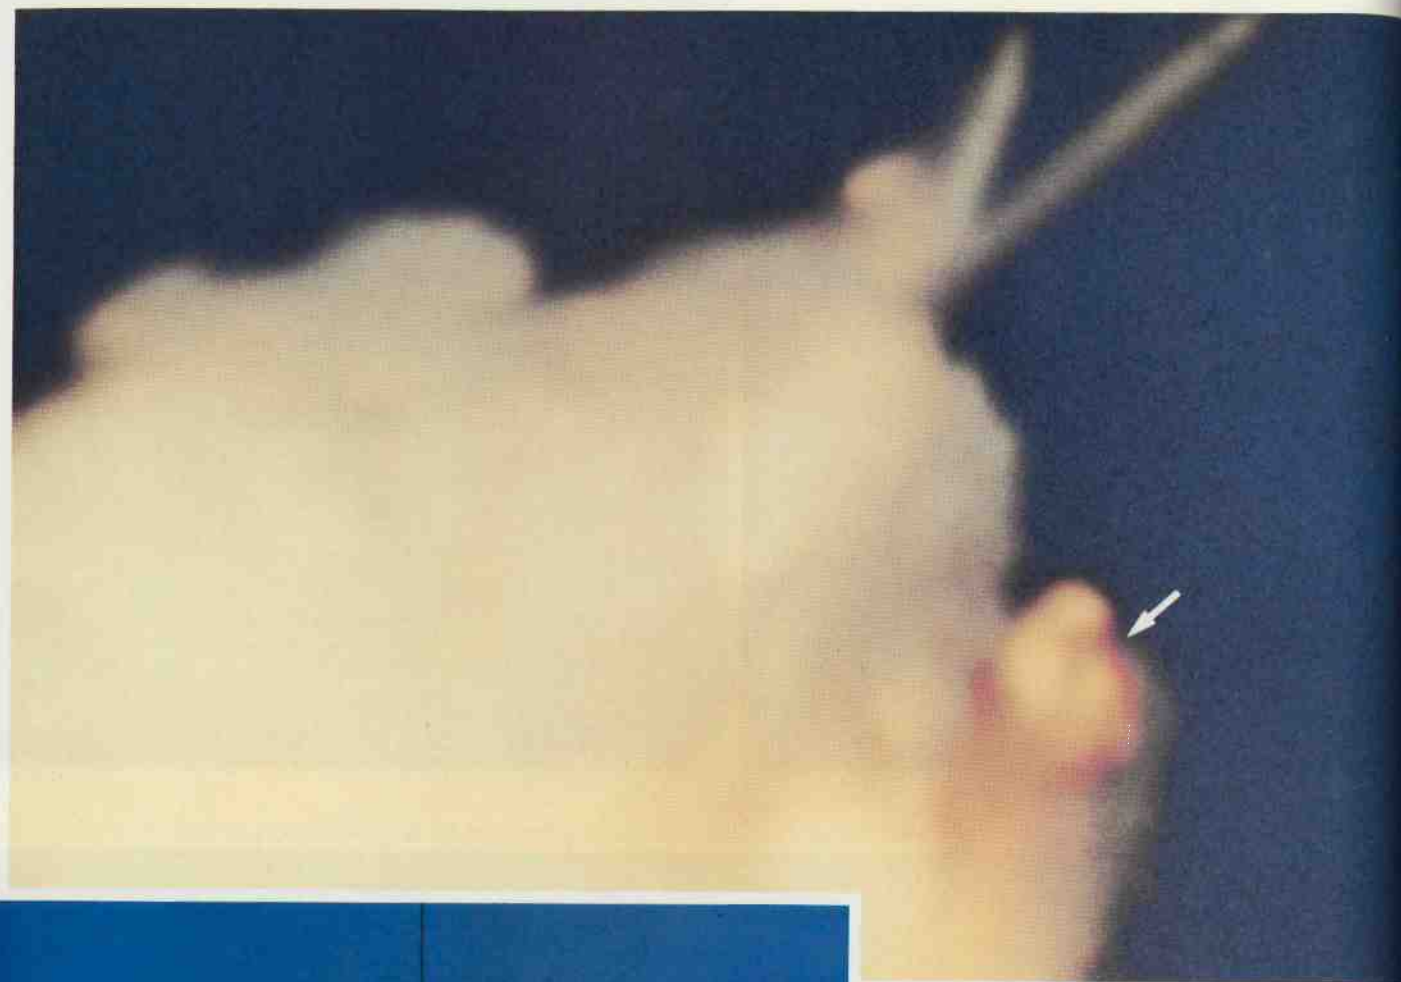
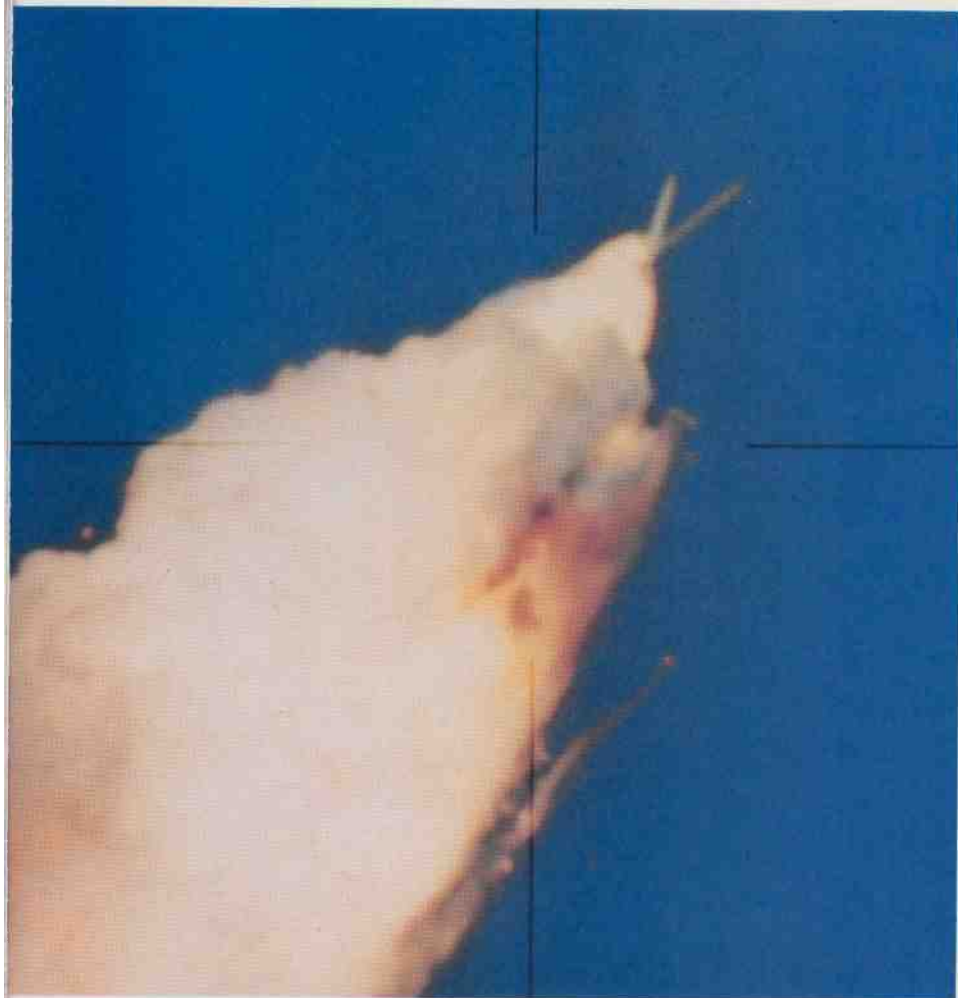
Structural breakup of the vehicle began at approximately 73 seconds. Fire spread very rapidly. Above, a bright flash (arrow) is evident near the nose of the Orbiter, suggesting spillage and ignition of the spacecraft's reaction control system propellants. At left, the two Solid Rocket Boosters thrust away from the fire, crisscrossing to form a "V." The right booster—identifiable by its failure plume—now to the left of its counterpart. At right, the boosters diverge farther; the External Tank wreckage is obscured by smoke and vapor. The Orbiter engines still firing, is visible at bottom center.
