Report of the

# PRESIDENTIAL COMMISSION

*on the Space Shuttle  
Challenger Accident*

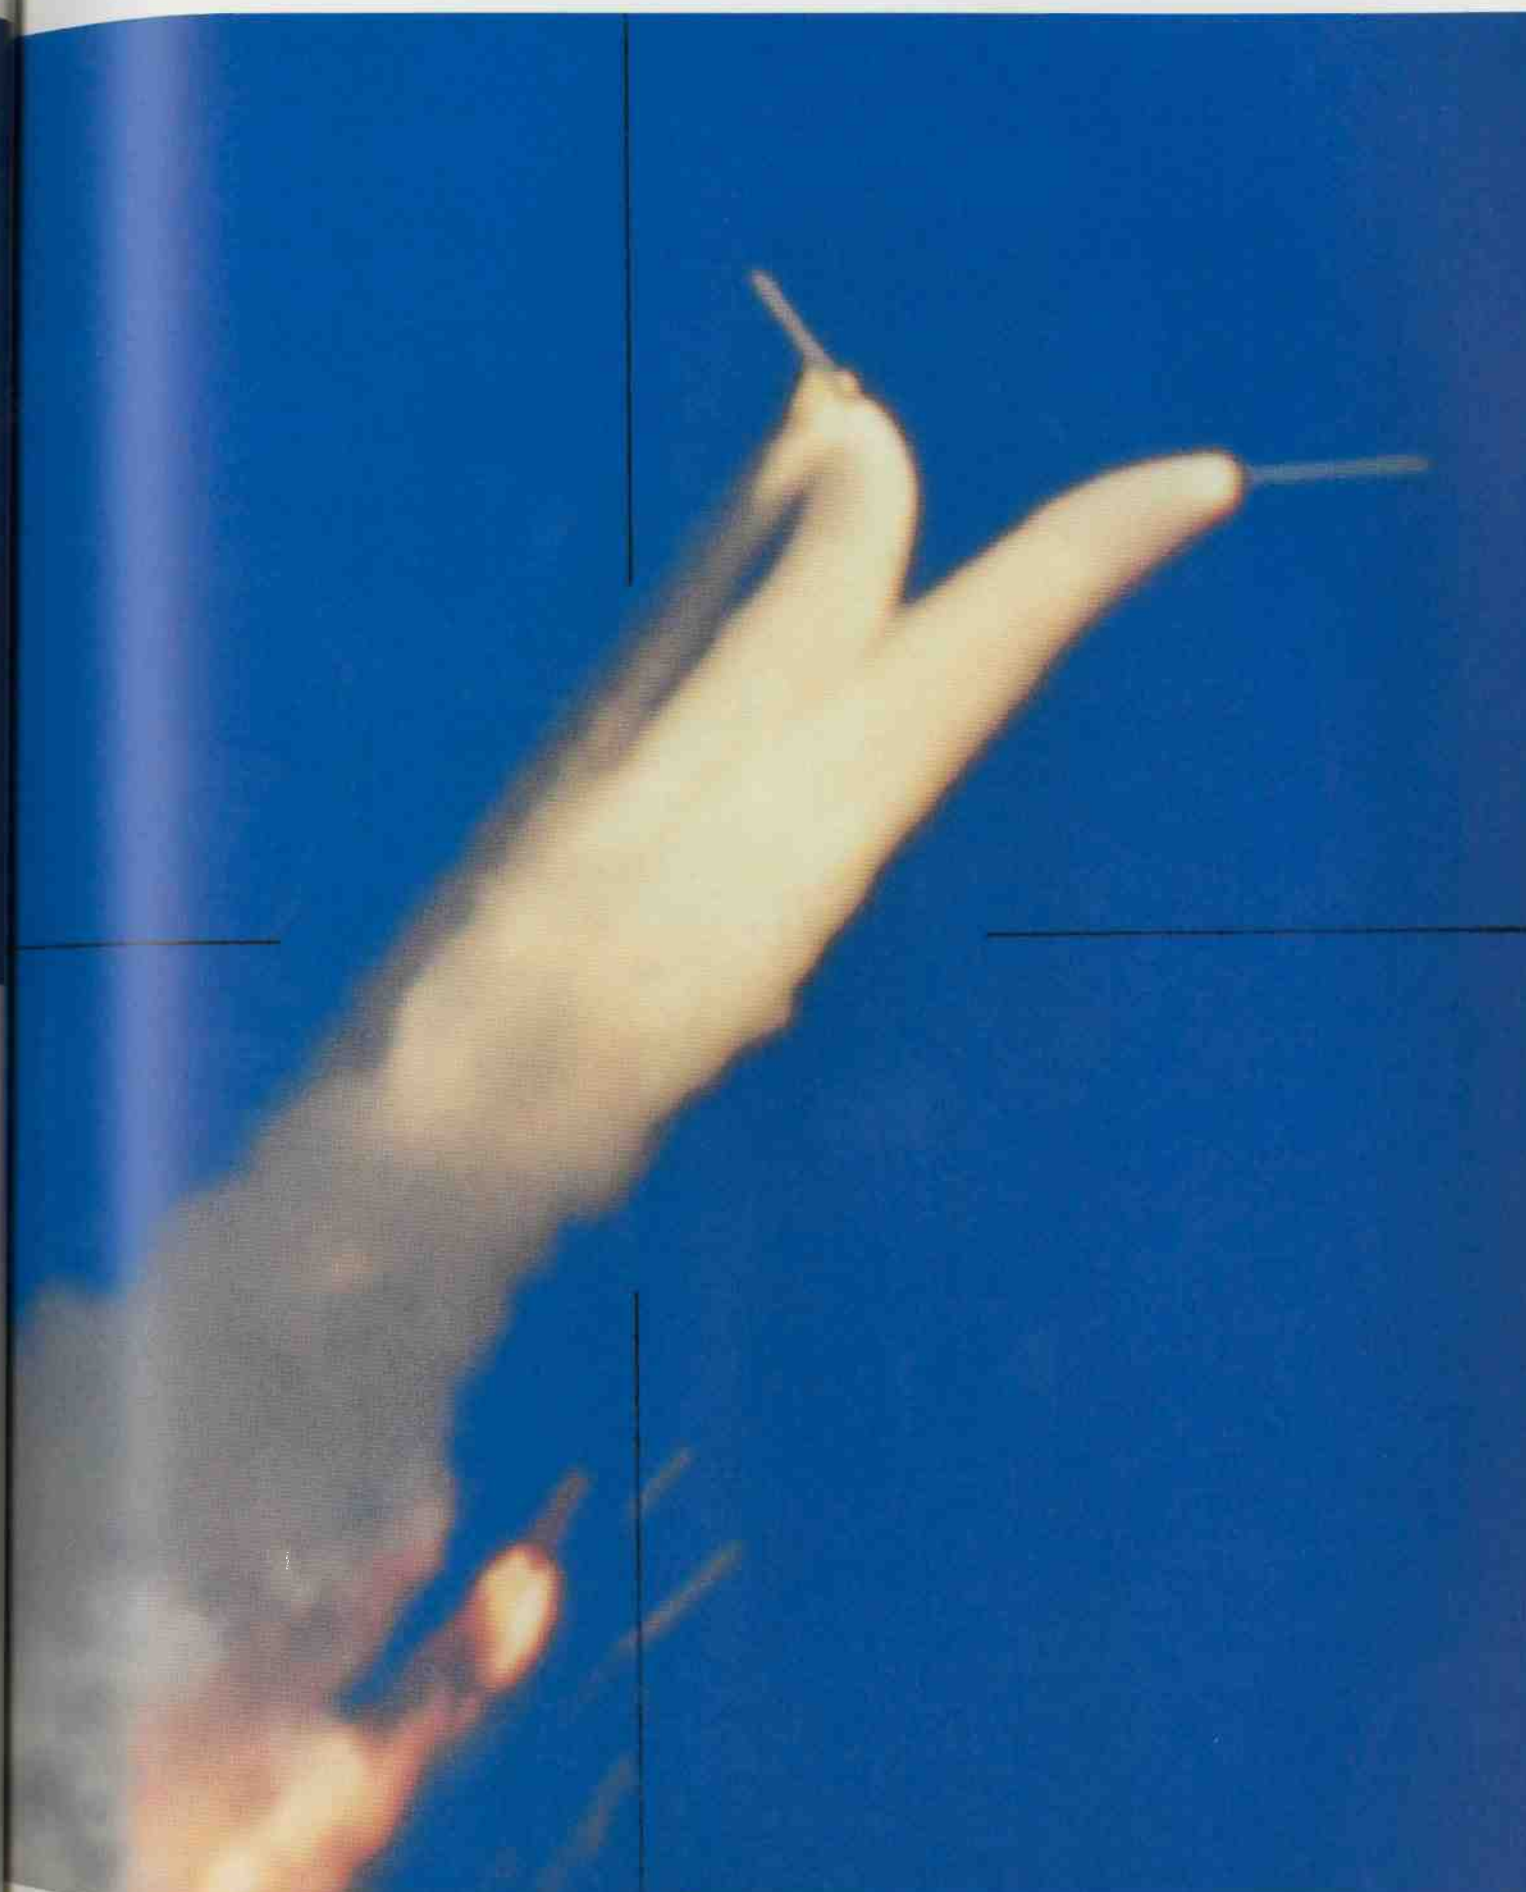
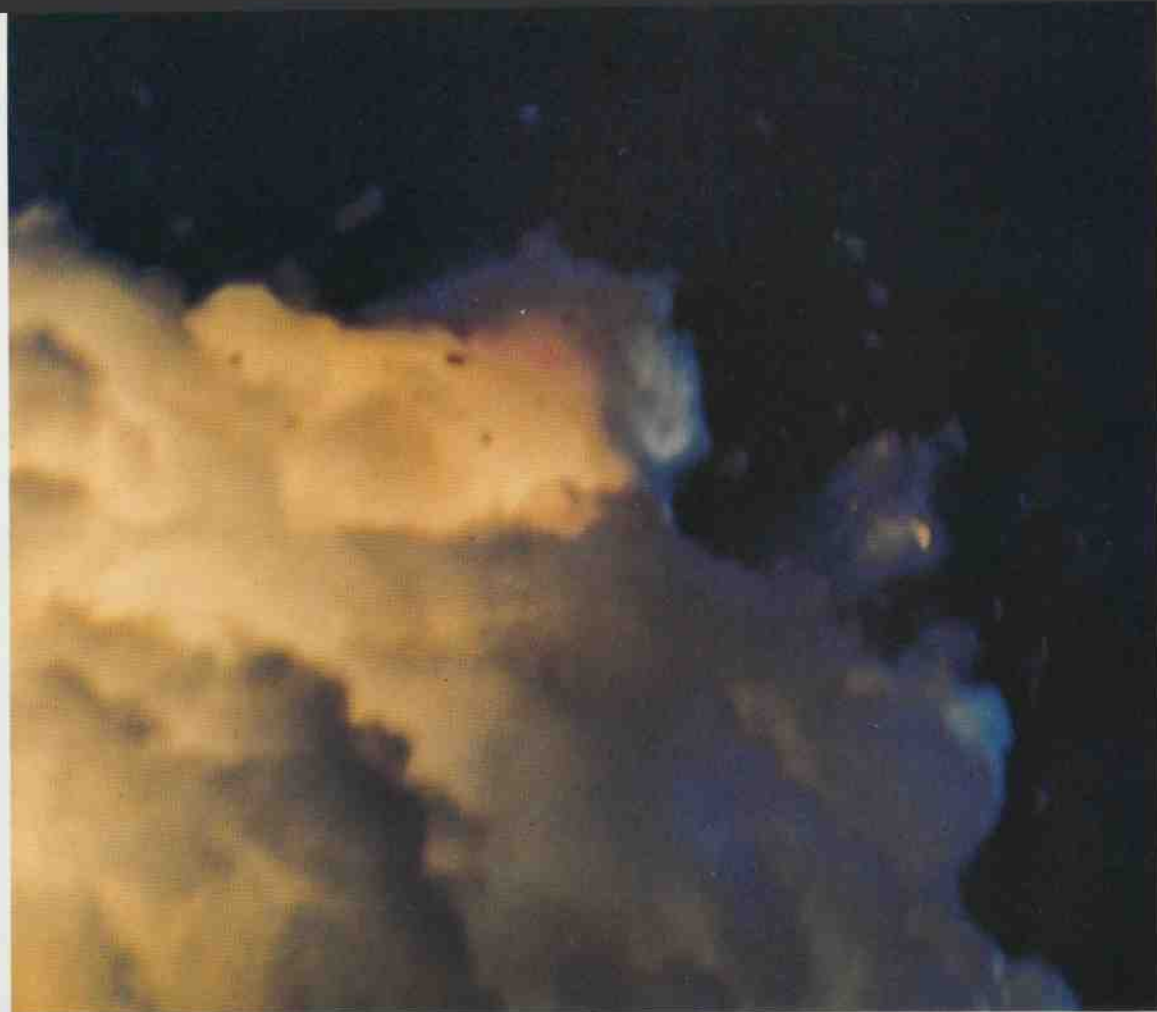
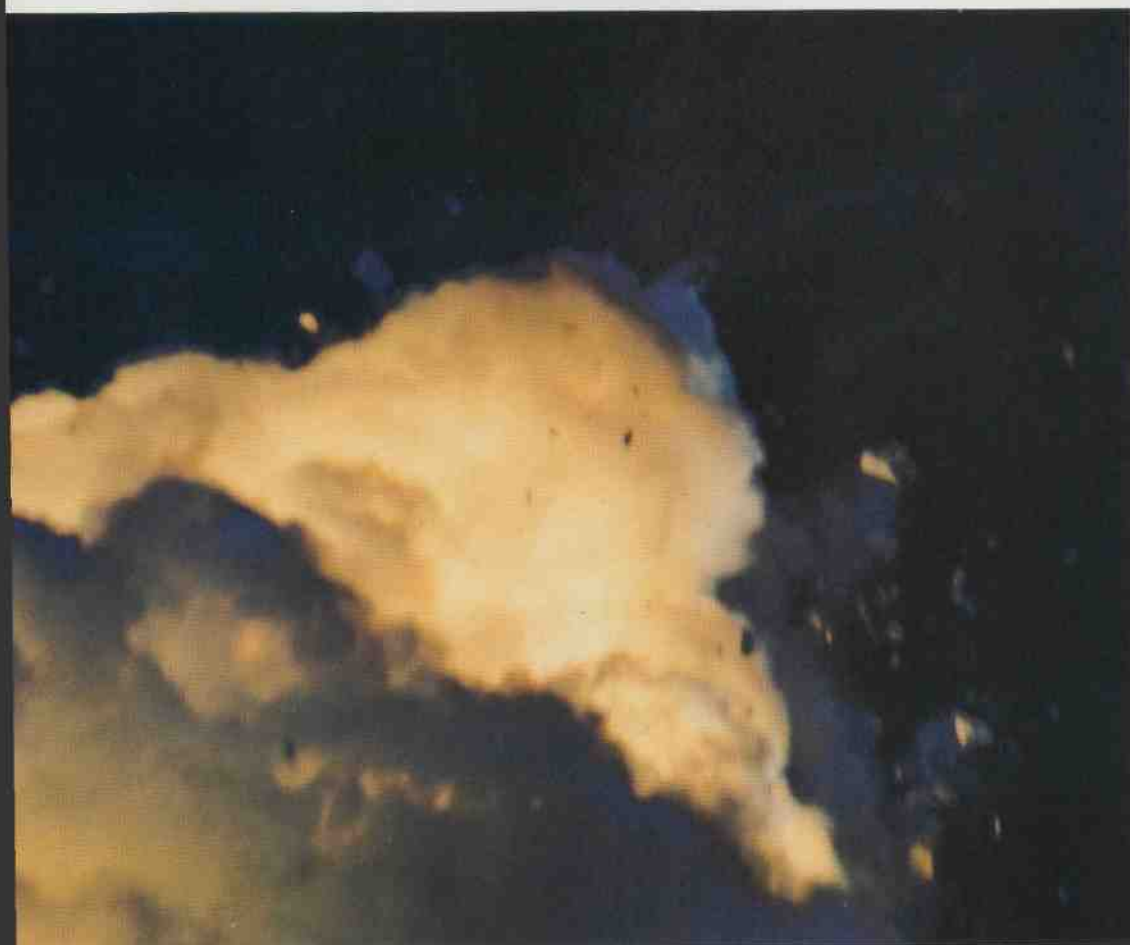
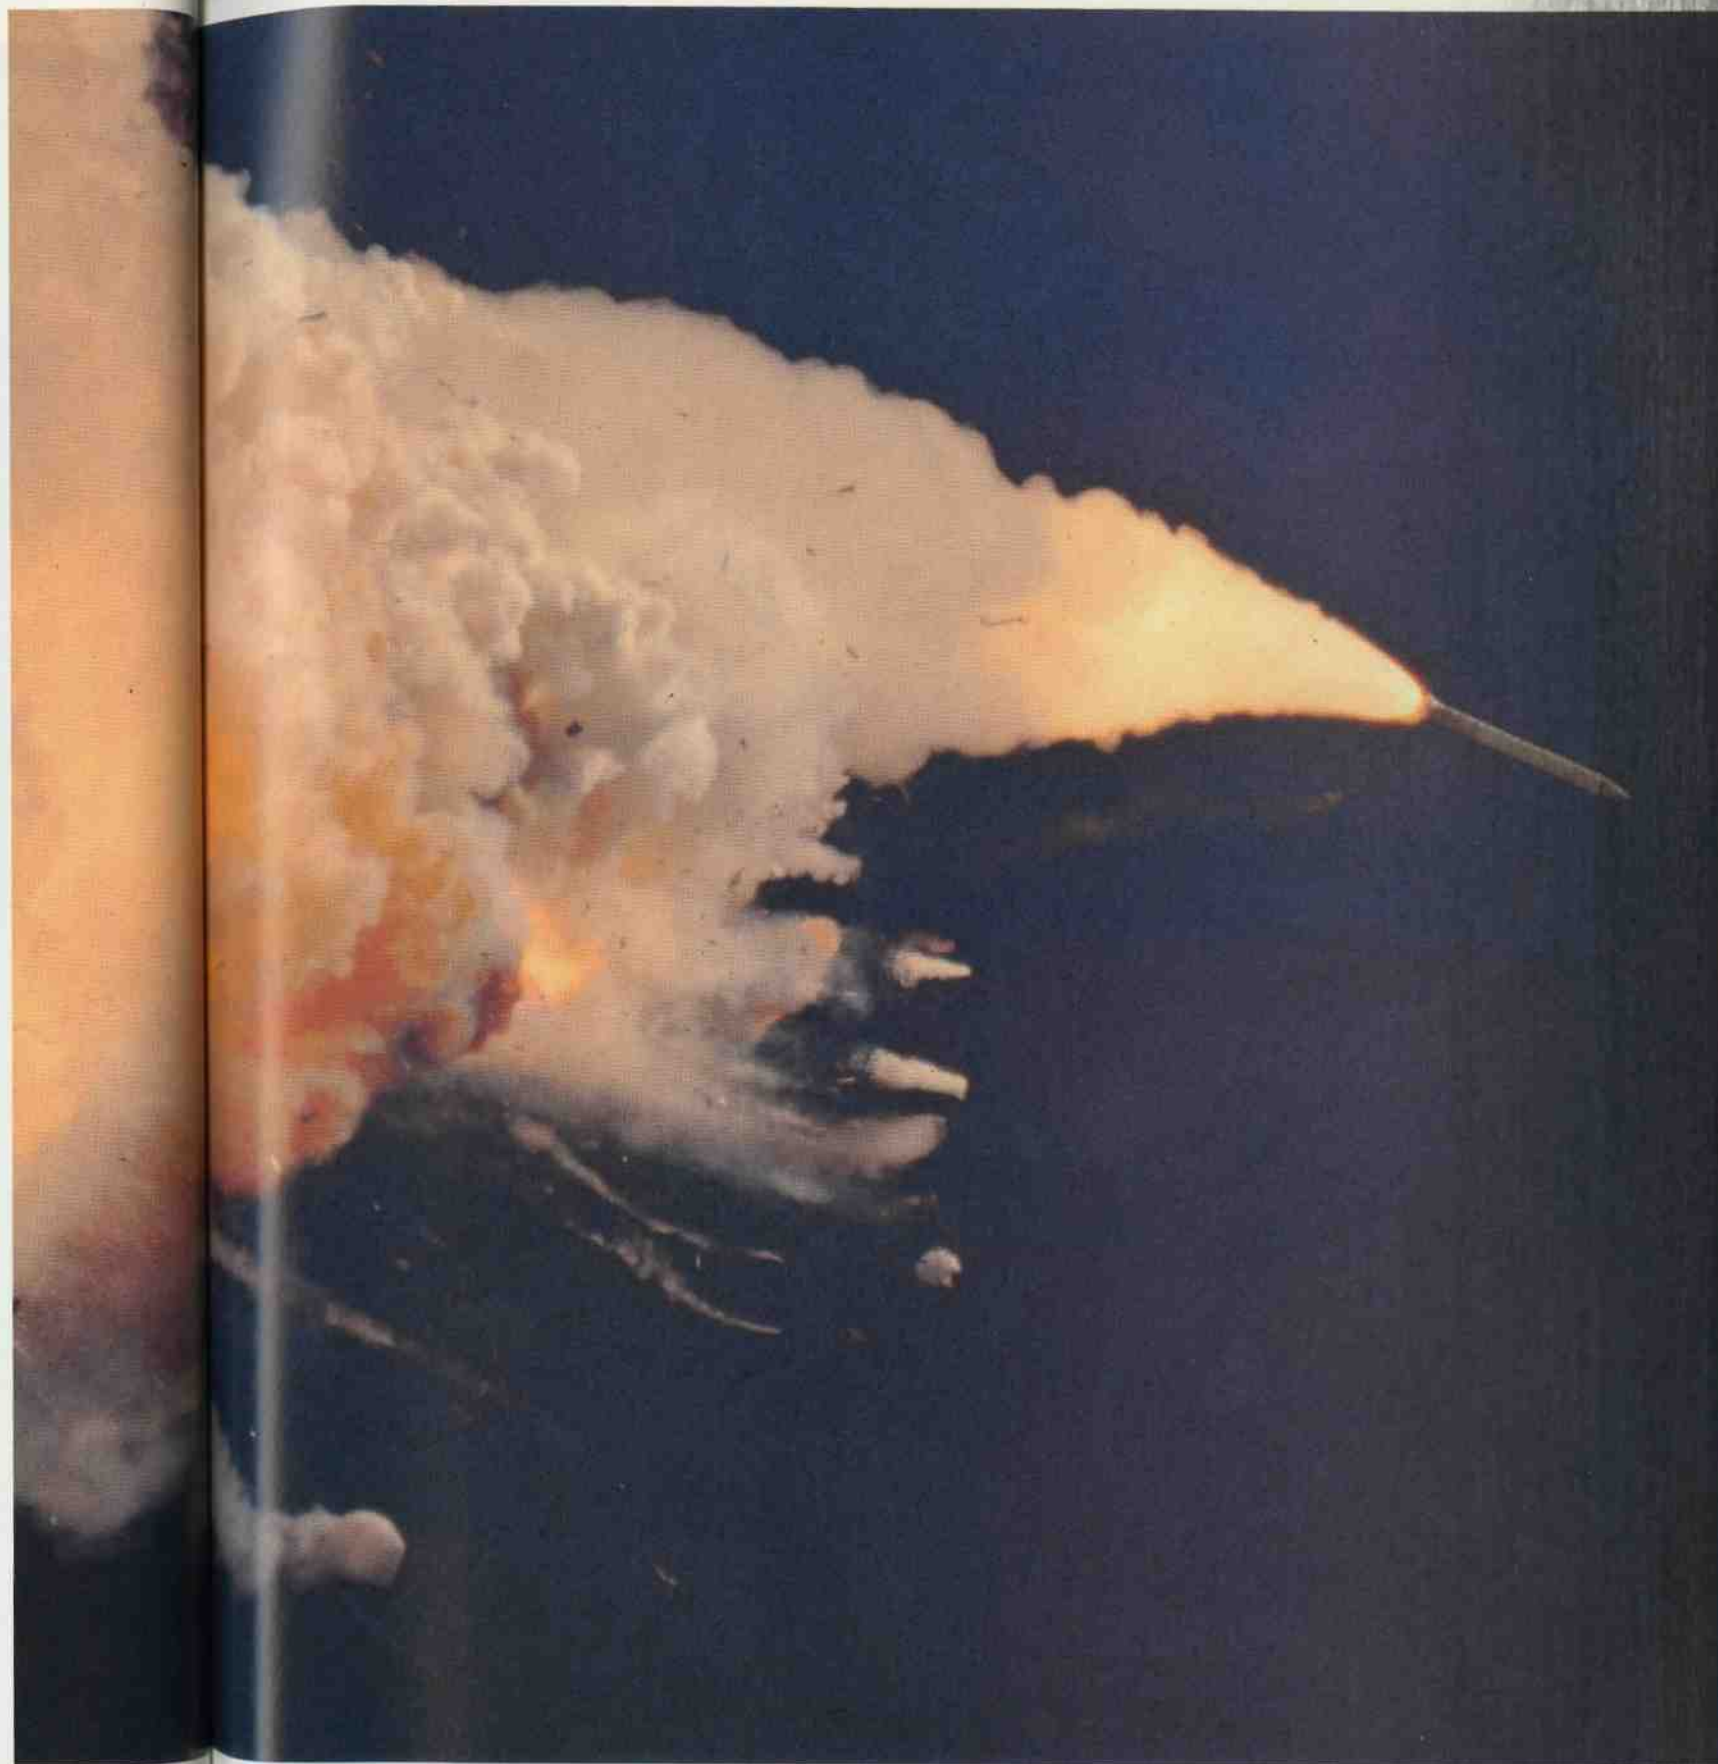
At about 76 seconds, unidentifiable fragments of the Shuttle vehicle can be seen tumbling against a background of fire, smoke and vaporized propellants from the External Tank (left). In the photo at right, the left booster (far right)

soars away, still thrusting. The reddish-brown cloud envelops the disintegrating Orbiter. The color is characteristic of the nitrogen tetroxide oxidizer in the Orbiter Reaction Control System propellant.

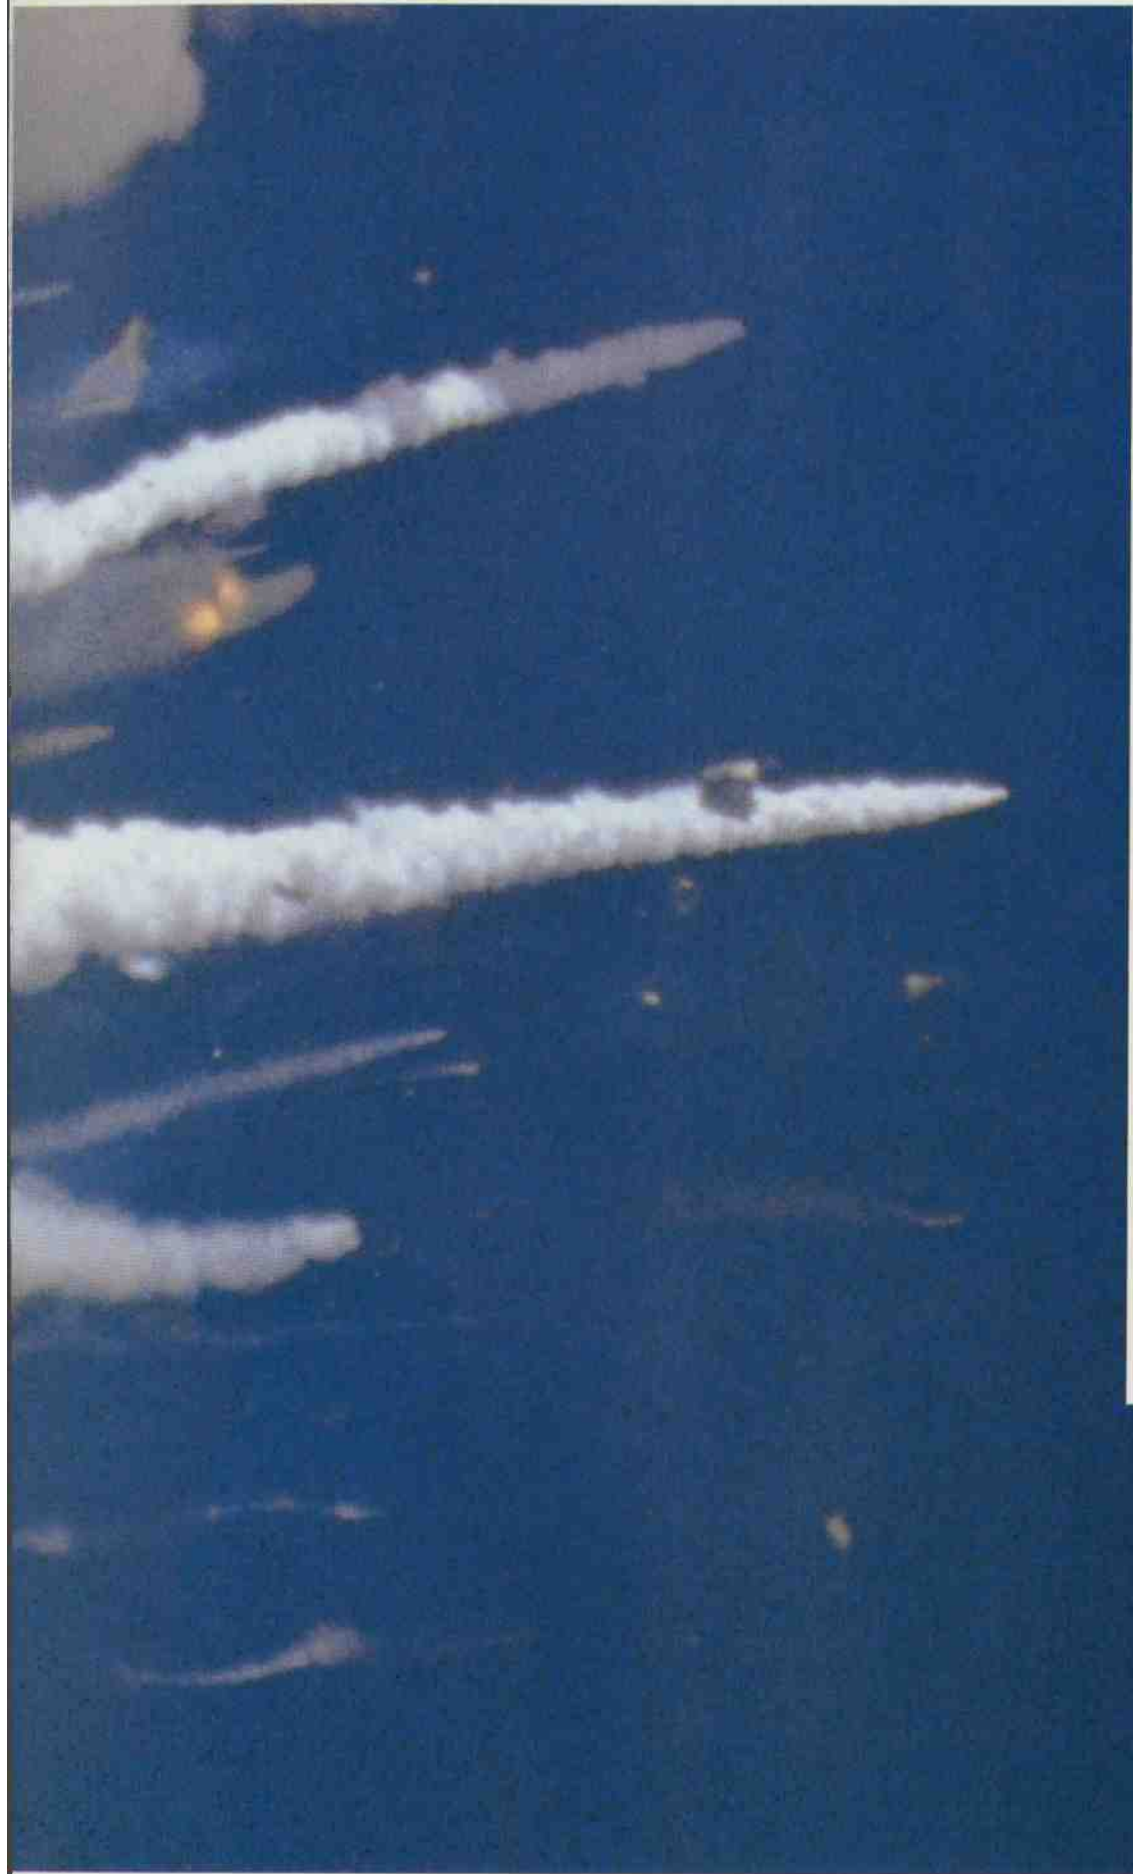
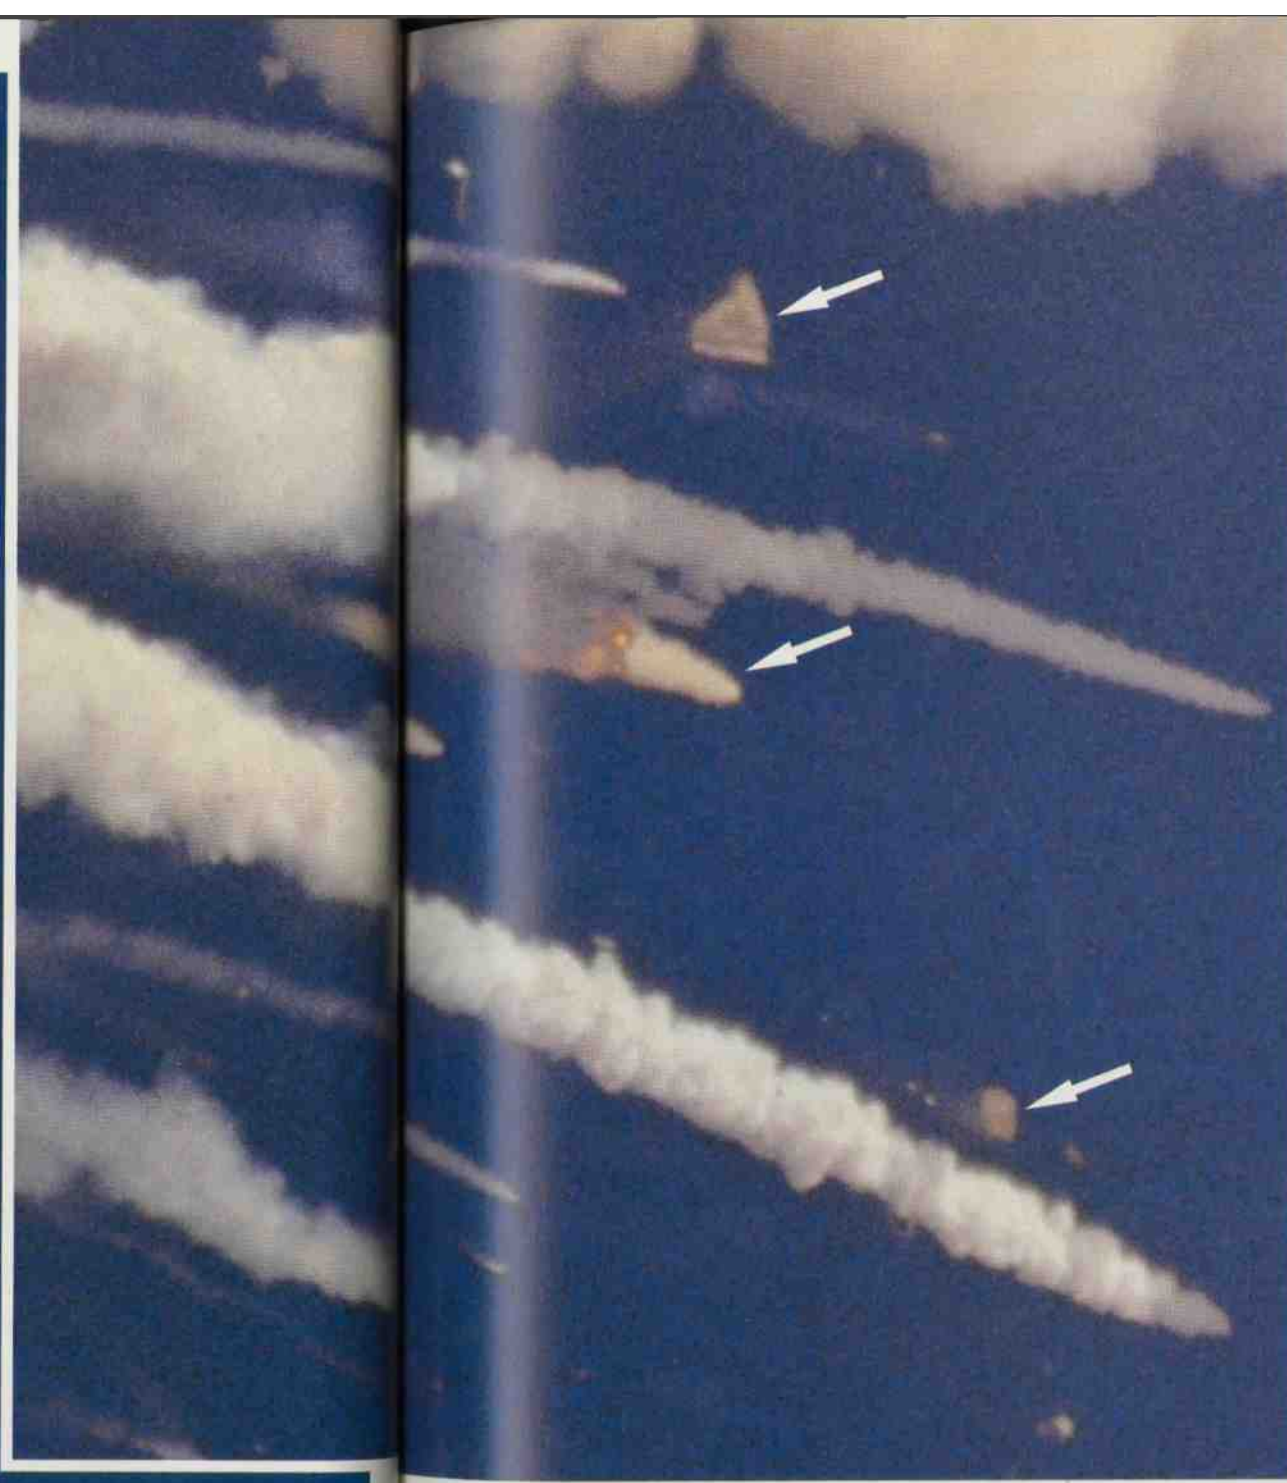
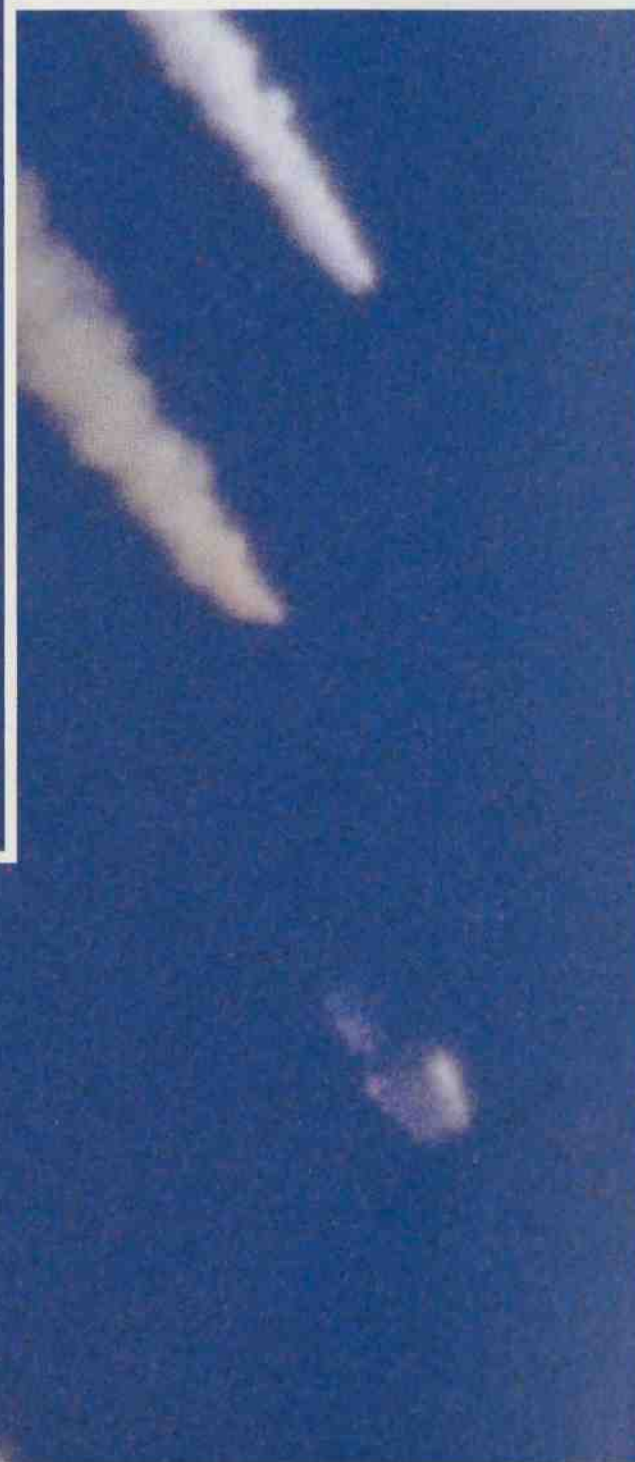
Hurling out of the fireball at 78 seconds (left) are the Orbiter's left wing (top arrow), the main engines (center arrow) and the forward fuselage (bottom arrow). In the photo below, it plunges Earthward, trailed by smoking fragments of Challenger.

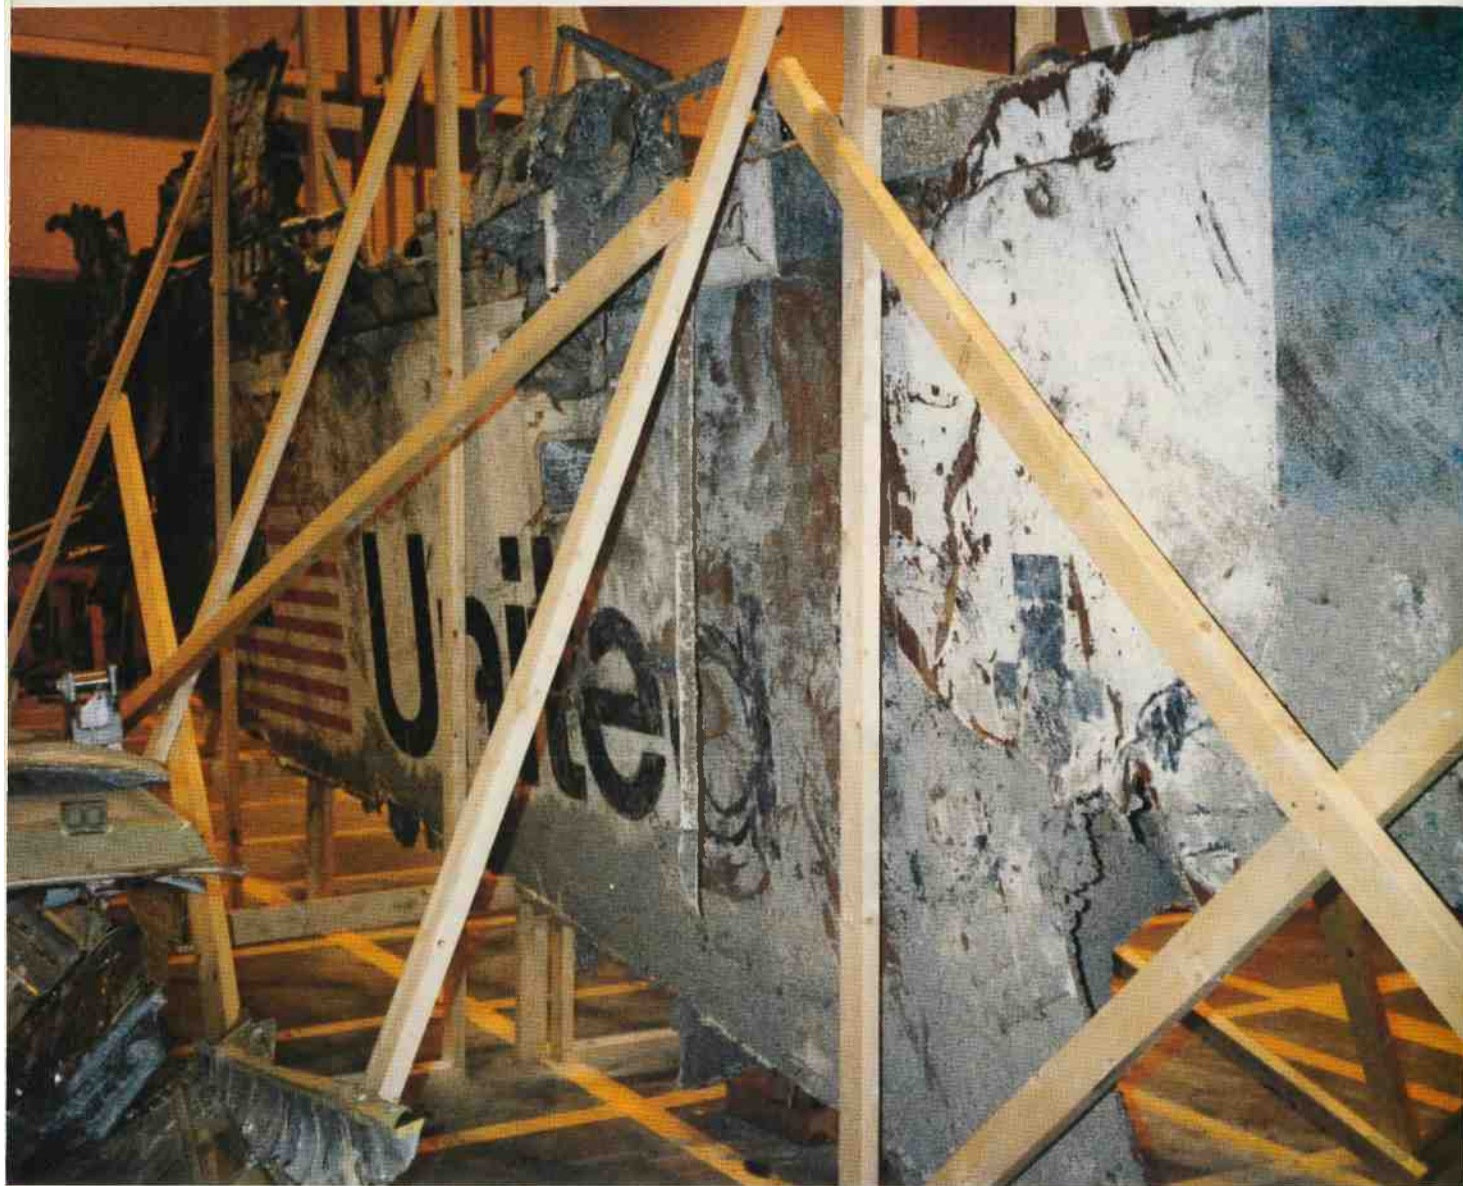
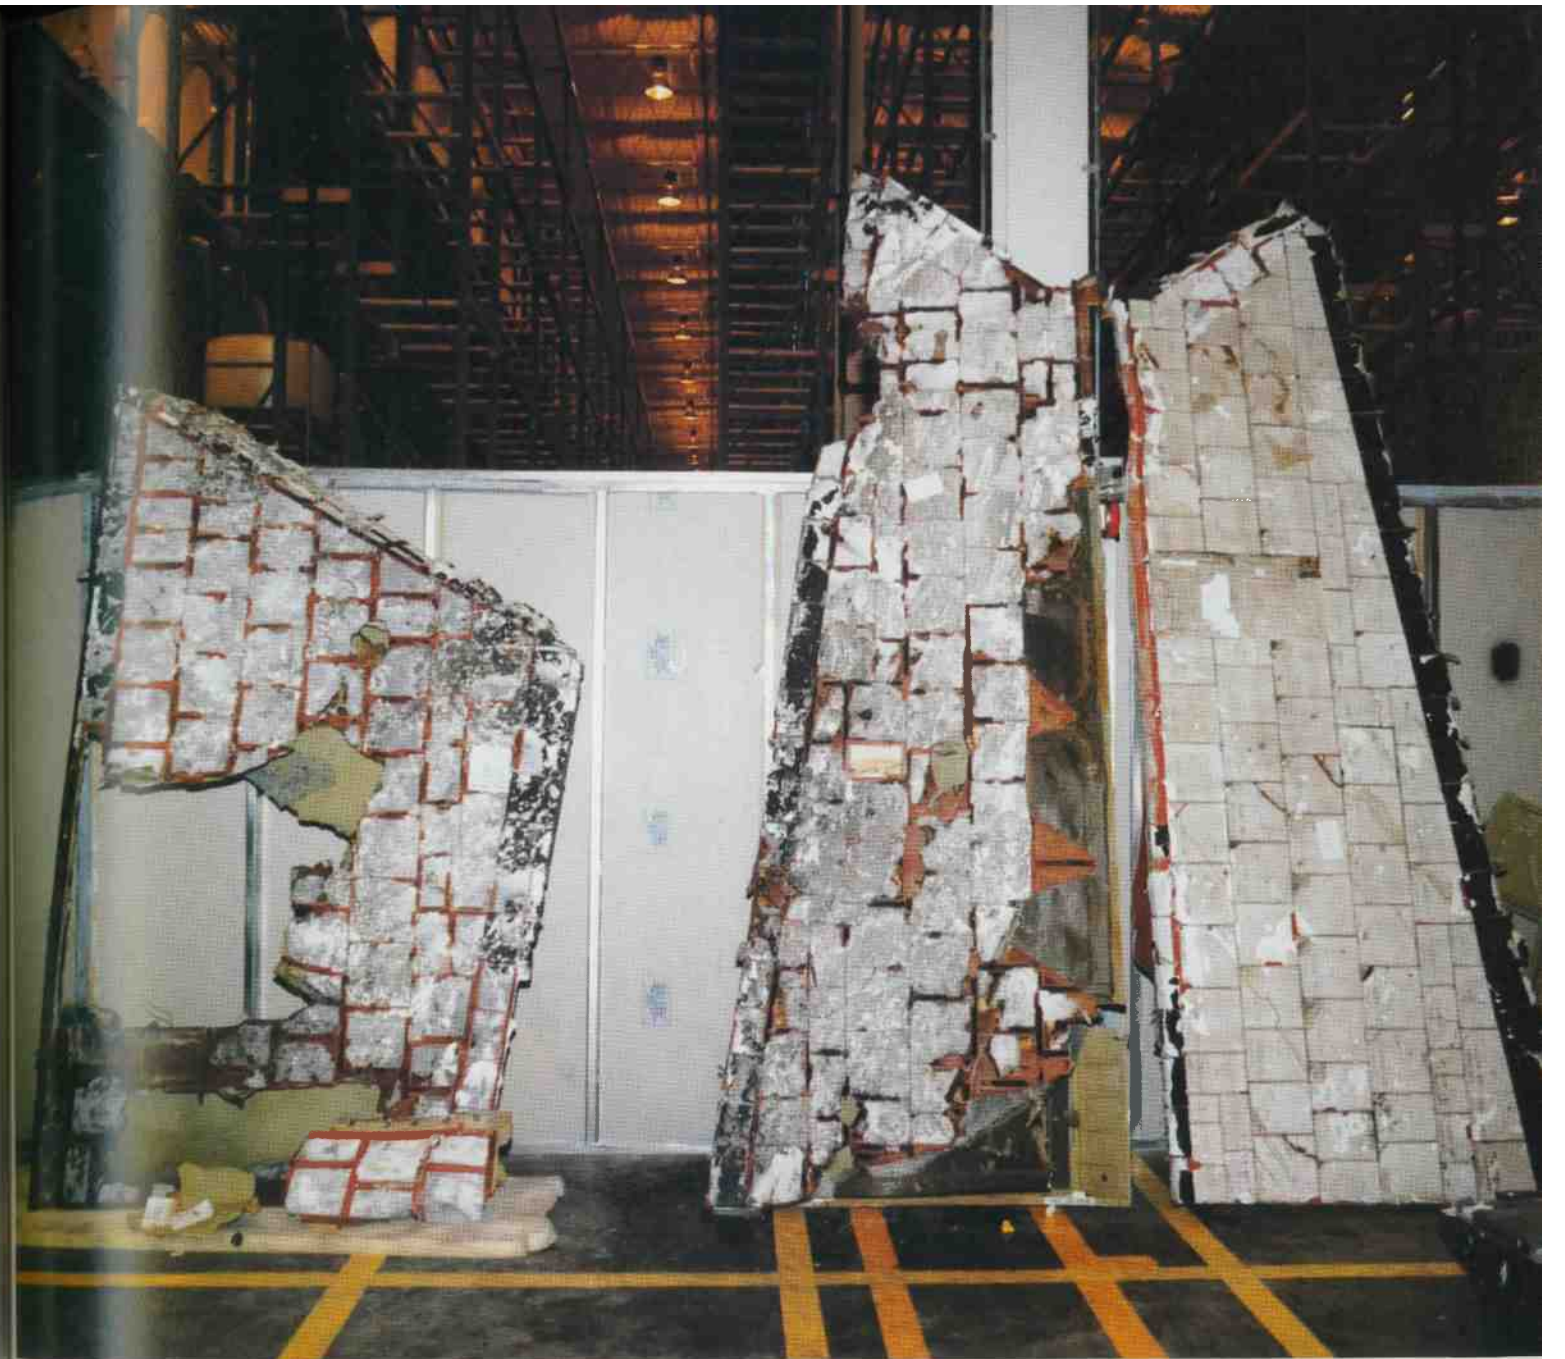
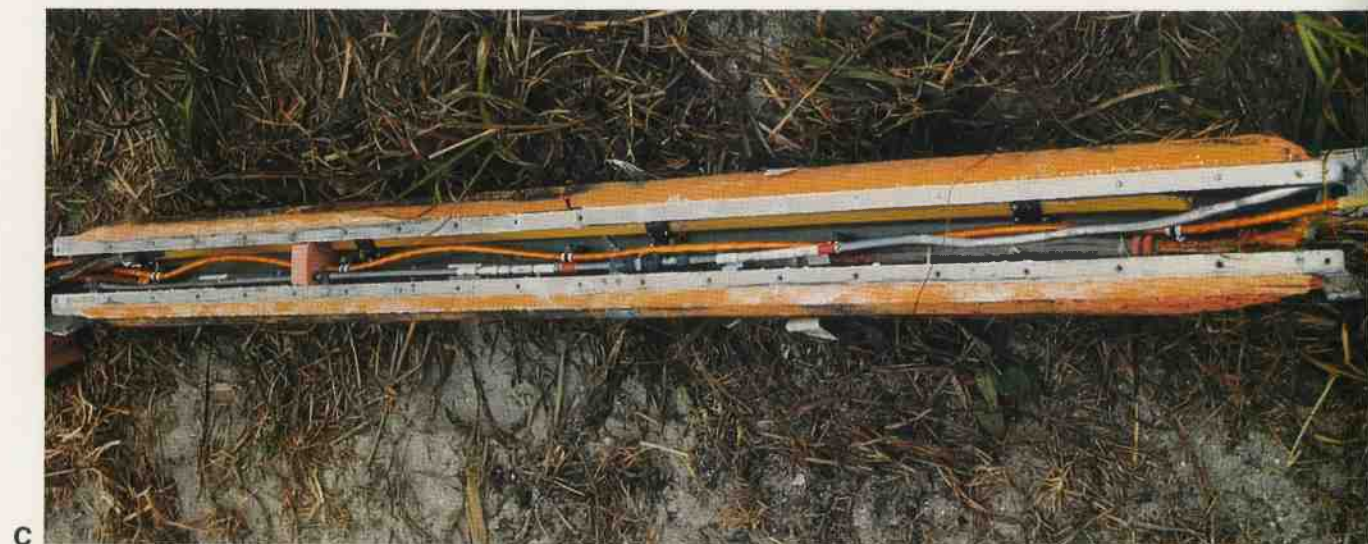
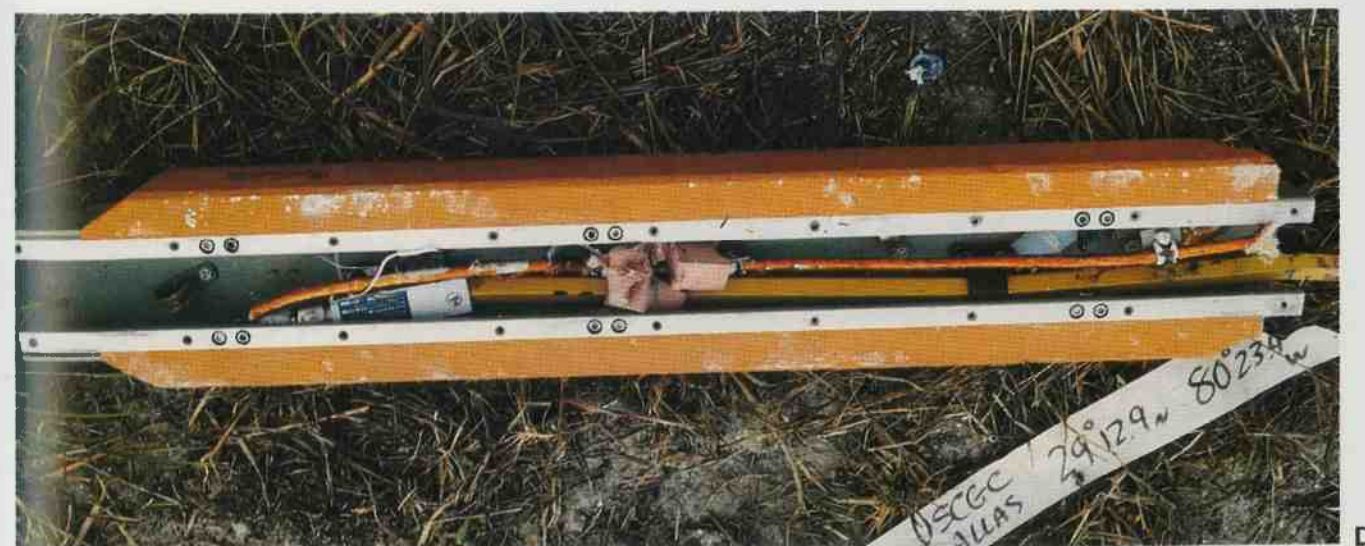
A The upper photos show, from left to right, the left side of the Orbiter (unburned), the right lower and upper rudder speed brake (both burn damaged) and left upper speed brake (unburned), confirmation that the fire was on the right side of the Shuttle stack. The lower photos show the range safety destruct charges in the External Tank. These charges were exonerated when they were recovered intact and undetonated.
